Access Compliance Report Public Rights-of-Way (Curb Ramps)

Intersection ID: 14726 Main Street: REMOUNT RD Cross Street: S_TRYON_ST Location: W ADA ID: 623463773B70 Ramp Type: Perp Initial Pass/Fail: Fail **Overall Compliance: No** Severity Score: 33.75

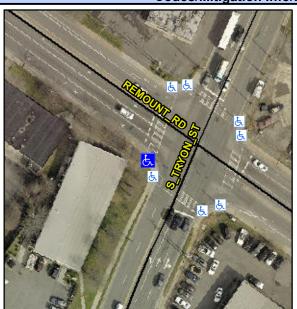
Possible Solutions:	Compli	ance Description
Remove & Replace Entire Ramp.	N/A	Ramp Length (in)
•	No	Ramp Width (in)
	N/A	Flare Type LT
	N/A	Flare Slope LT (%)
	N/A	Flare Traversable LT
	N/A	Landing Length (in)
Surveyor Notes:	N/A	Landing Width (in)
N/A	N/A	Landing Slope (%)
	N/A	Landing X Slope (%)
	N/A	Landing Curb? (Y/N)
	N/A	Shared Landing?
PROW/ADA:	N/A	Gutter Ponding?
Not Found, R304.5.1, R304.2.2,	N/A	Gutter Lip Ht (in)
R304.5.3	N/A	Painted X Walk1?
		X Walk 1 Direction
	N/A	X Walk 1 Width (in)
		X Walk 1 Slope (%)
		X Walk 1 X Slope (%
	NI/A	Daman in side VM-II-
