# Access Compliance Report

## Public Rights-of-Way

### (Curb Ramps)

| Intersection ID: 32245 | Main Street: BALMORAL_PARK_DR | Cross Street: OXFORD_COMMONS_DR | Location: E |

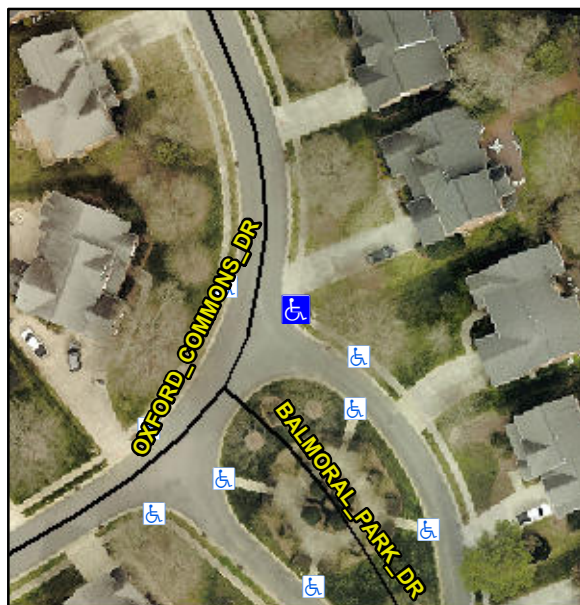
| ADA ID: 62421451E7AE | Ramp Type: Perp | Initial Pass/Fail: Fail | Overall Compliance: No |

**Not Found, R304.5.1**

| Compliance | Description | Data | Compliance | Description | Data |
|---|---|---|---|---|---|
| No | Ramp Width (in) | 38.0 | Yes | Ramp XSlope (%) | 3.4 |

**Remove & Replace Entire Ramp.**

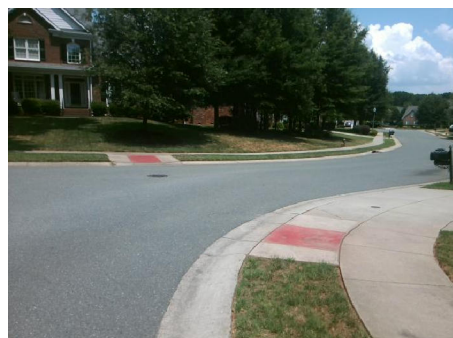
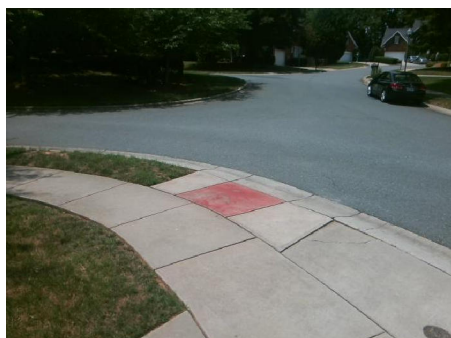
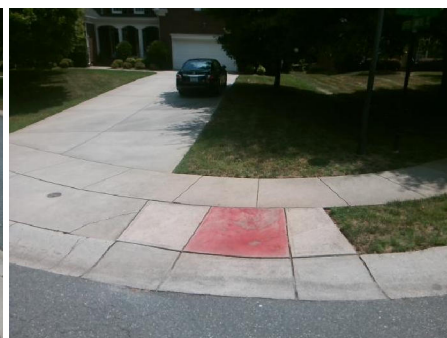
| Compliance | Description | Data | Compliance | Description | Data |
|---|---|---|---|---|---|
| | | | Yes | Surface Condition? (G/P) | Good |
