# Access Compliance Report

## Public Rights-of-Way

### (Curb Ramps)

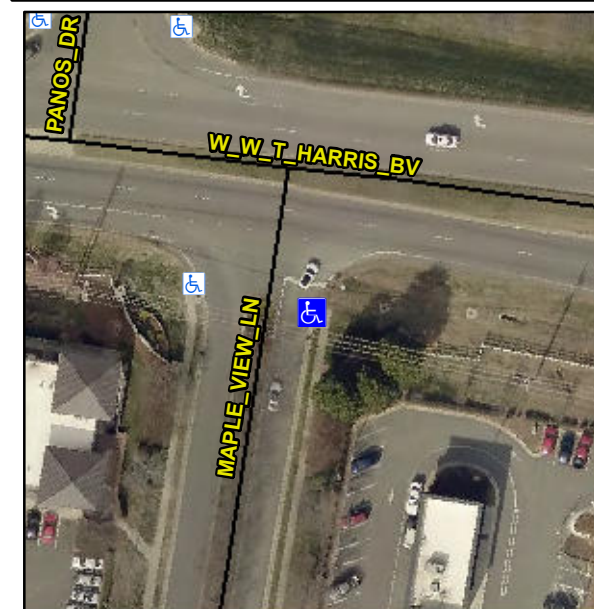
Intersection ID: 3495	Main Street: MAPLE_VIEW_LN	Cross Street: W_W_T_HARRIS_BV	Location: SE
ADA ID: 6245A1AB3C8E	Ramp Type: Perp	Initial Pass/Fail: Fail	Overall Compliance: No
Severity Score: 21.25			
Codes/Mitigation Info/Possible Solution		Field Measurements/Component Compliance

**Not Found, R304.5.1, R304.2.2**

Compliance	Description	Data	Compliance	Description	Data
N/A	Ramp Length (in)	47.0	No	Ramp Slope (%)	10.6
No	Ramp Width (in)	45.0	Yes	Ramp XSlope (%)	1.5
N/A	Flare Type LT	N/A	N/A	Flare Type RT	N/A
N/A	Flare Slope LT (%)	N/A	N/A	Flare Slope RT (%)	N/A
N/A	Flare Traversable LT?	N/A	N/A	Flare Traversable RT?	N/A
N/A	Landing Length (in)	N/A	N/A	DWS Provided?	N/A
N/A	Landing Width (in)	N/A	N/A	DWS Contrast?	N/A
N/A	Landing Slope (%)	N/A	N/A	DWS Length (in)	N/A
N/A	Landing X Slope (%)	N/A	N/A	DWS Full Width?	N/A
N/A	Landing Curb? (Y/N)	N/A	N/A	DWS Offset (in)	N/A
N/A	Shared Landing?	N/A			
N/A	Gutter Ponding?	N/A	N/A	Gutter Slope (%)	N/A
N/A	Gutter Lip Ht (in)	N/A	N/A	Gutter X Slope (%)	N/A
N/A	Painted X Walk1?	No	N/A	Painted X Walk2?	N/A
	X Walk 1 Direction	To W		X Walk 2 Direction	N/A
N/A	X Walk 1 Width (in)	N/A	N/A	X Walk 2 Width (in)	N/A
	X Walk 1 Slope (%)	0.9		X Walk 2 Slope (%)	N/A
	X Walk 1 X Slope (%)	3.6		X Walk 2 X Slope (%)	N/A

**Remove & Replace Entire Ramp.**
