Access Compliance Report

Public Rights-of-Way

(Curb Ramps)

| Intersection ID: 5124 | Main Street: GIBBON_RD | Cross Street: OLD_STATESVILLE_RD | Location: E |

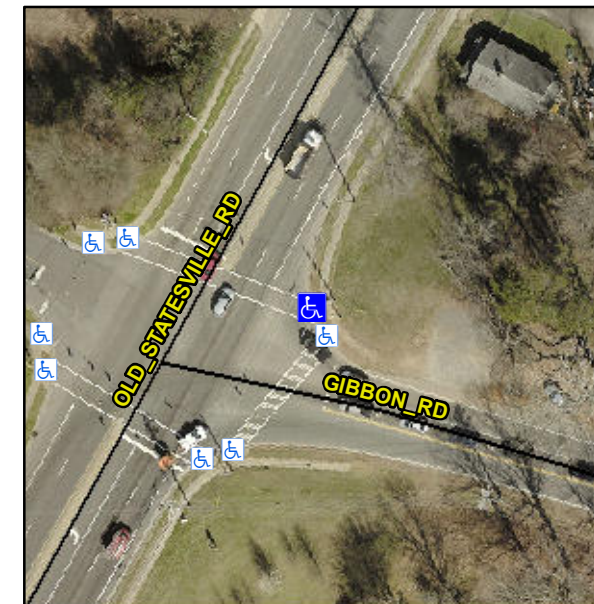
Not Found, R304.5.1, R304.2.2

| Compliance | Description | Data | Compliance | Description | Data |
|---|---|---|---|---|---|
| N/A | Ramp Length (in) | 59.0 | No | Ramp Slope (%) | 13.1 |
| No | Ramp Width (in) | 41.0 | Yes | Ramp XSlope (%) | 0.9 |

Remove & Replace Entire Ramp.

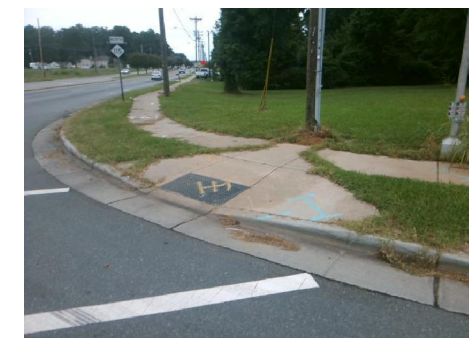
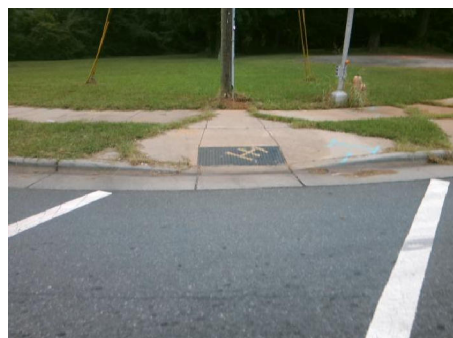
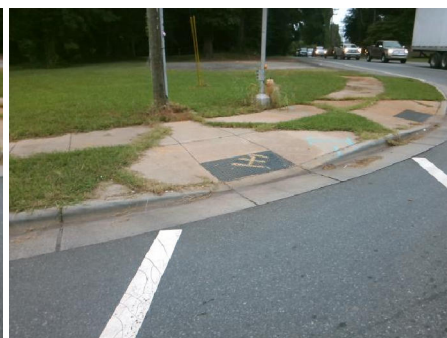
| Compliance | Description | Data | Compliance | Description | Data |
|---|---|---|---|---|---|
| | | Yes | | Surface Condition? (G/P) | Good |
