# Access Compliance Report

## Public Rights-of-Way

### (Curb Ramps)

Intersection ID: 13296	Main Street: CENTRAL_AV	Cross Street: MORNINGSIDE_DR	Location: SE
ADA ID: 62846FA93CB7	Ramp Type: Perp	Initial Pass/Fail: Fail	Overall Compliance: No
		Severity Score: 8.75

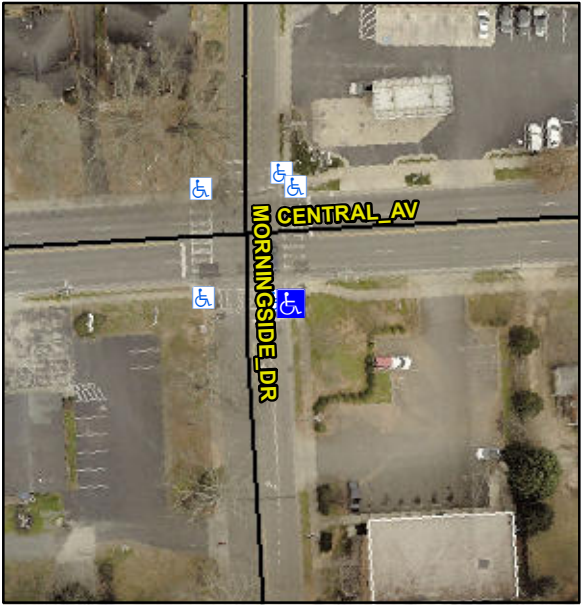
Possible Solutions:		<b>Compliance</b>	<b>Description</b>	<b>Data</b>
	<b>Remove &amp; Replace Entire Ramp.</b>		<b>Yes</b>	Ramp Length (in)	38.0
			<b>No</b>	Ramp Width (in)	40.0
			<b>N/A</b>	Flare Type LT	N/A
			<b>N/A</b>	Flare Slope LT (%)	N/A
			<b>N/A</b>	Flare Traversable LT?	N/A
			<b>N/A</b>	Landing Length (in)	N/A
			<b>N/A</b>	Landing Width (in)	N/A
			<b>N/A</b>	Landing Slope (%)	N/A
			<b>N/A</b>	Landing X Slope (%)	N/A
<p>Surveyor Notes:</p> <p><b>N/A</b></p> <p>PROW/ADA:</p> <p><b>Not Found, R304.5.1</b></p>			<b>N/A</b>	Flare Type RT	N/A
			<b>N/A</b>	Flare Slope RT (%)	N/A
			<b>N/A</b>	Flare Traversable RT?	N/A
			<b>N/A</b>	DWS Provided?	N/A
			<b>N/A</b>	DWS Contrast?	N/A
			<b>N/A</b>	DWS Length (in)	N/A
			<b>N/A</b>	DWS Full Width?	N/A
			<b>N/A</b>	DWS Offset (in)	N/A
			<b>N/A</b>	Shared Landing?	N/A

<b>N/A</b>	Gutter Ponding?	N/A
			<b>N/A</b>	Gutter Lip Ht (in)	N/A
			<b>N/A</b>	Painted X Walk1?	Yes
				X Walk 1 Direction	To N
			<b>N/A</b>	X Walk 1 Width (in)	110.0
				X Walk 1 Slope (%)	4.3
				X Walk 1 X Slope (%)	2.3
			<b>N/A</b>	Ramp inside XWalk1?	Yes
			<b>N/A</b>	Road Slope (%)	N/A
			<b>N/A</b>	Road X Slope (%)	N/A
			<b>N/A</b>	Any Obstructions?	N/A
				Obstruction Type	
			<b>N/A</b>		
			<b>N/A</b>		
			<b>N/A</b>		
			<b>N/A</b>		
			<b>N/A</b>		
			<b>N/A</b>		
			<b>N/A</b>		
			<b>N/A</b>		
			<b>N/A</b>		
Total Cost:		\$ 1850.00			
Street 1 Name	CENTRAL AV				
Stop Condition-Street 2	Signal				
Street 2 Name	N/A				
Stop Condition-Street 1	N/A				
			<b>N/A</b>	Clear Space?	N/A
			<b>N/A</b>	Clear Space to XWalk (in)	N/A
			<b>N/A</b>	Storm Grate/Utility Hazard?	N/A
			<b>N/A</b>	Storm Grate/Utility Type	N/A
			<b>Yes</b>	Surface Condition? (G/P)	Good
