# Access Compliance Report

## Public Rights-of-Way

### (Curb Ramps)

Intersection ID: 14869	Main Street: MEACHAM_ST	Cross Street: OLMSTED_PARK_PL	Location: W
ADA ID: 629F54B3812D	Ramp Type: PerpDiag	Initial Pass/Fail: Fail	Overall Compliance: No
			Severity Score: 21.25

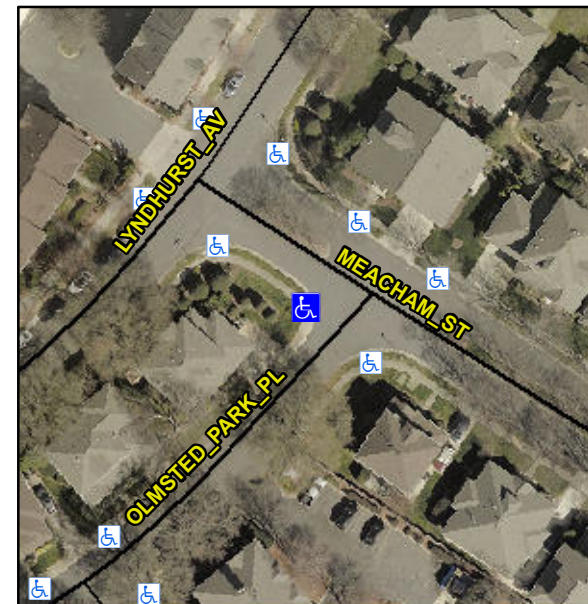
**Not Found, R304.5.1, R304.5.3**

Compliance	Description	Data	Compliance	Description	Data
N/A	Ramp Length (in)	68.0	Yes	Ramp Slope (%)	6.9
No	Ramp Width (in)	39.0	No	Ramp XSlope (%)	5.1
N/A	Flare Type LT	N/A	N/A	Flare Type RT	N/A
N/A	Flare Slope LT (%)	N/A	N/A	Flare Slope RT (%)	N/A
N/A	Flare Traversable LT?	N/A	N/A	Flare Traversable RT?	N/A
N/A	Landing Length (in)	N/A	N/A	DWS Provided?	N/A
N/A	Landing Width (in)	N/A	N/A	DWS Contrast?	N/A
N/A	Landing Slope (%)	N/A	N/A	DWS Length (in)	N/A
N/A	Landing X Slope (%)	N/A	N/A	DWS Full Width?	N/A
N/A	Landing Curb? (Y/N)	N/A	N/A	DWS Offset (in)	N/A
N/A	Shared Landing?	N/A			
N/A	Gutter Ponding?	N/A	N/A	Gutter Slope (%)	N/A
N/A	Gutter Lip Ht (in)	N/A	N/A	Gutter X Slope (%)	N/A
N/A	Painted X Walk1?	No	N/A	Painted X Walk2?	No
	X Walk 1 Direction	To SE		X Walk 2 Direction	To NE
N/A	X Walk 1 Width (in)	N/A	N/A	X Walk 2 Width (in)	N/A
	X Walk 1 Slope (%)	0.1		X Walk 2 Slope (%)	5.9
	X Walk 1 X Slope (%)	3.8		X Walk 2 X Slope (%)	0.3

N/A	Ramp inside XWalk1?	N/A	N/A	Ramp inside XWalk2?	N/A
	Road Slope (%)	2.2	N/A	Clear Space?	N/A
	Road X Slope (%)	3.1	N/A	Clear Space to XWalk (in)	N/A
N/A	Any Obstructions?	N/A	N/A	Storm Grate/Utility Hazard?	N/A
	Obstruction Type			Storm Grate/Utility Type	
		N/A			N/A
			Yes	Surface Condition? (G/P)	Good

**Remove & Replace Curb Ramp With Two New Directional Ramps or Equivalent.**
