Access Compliance Report Public Rights-of-Way (Curb Ramps)

Intersection ID: 50272 Main Street: SOUTH_BV Cross Street: WHITTON_ST Location: NW

ADA ID: 62A1103E2024 Ramp Type: Perp Initial Pass/Fail: Fail Overall Compliance: No Severity Score: 13.75

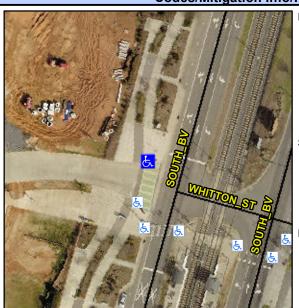
| Possible Solutions: |
|---|
| Not Found, R304.2.2, R304.5.3 |

| Field Measurements/Component Compliance | | | | | | | | |
|---|---|---|---|---|---|--|--|--|
| N/A | Ramp Length (in) | 70.0 | No | Ramp Slope (%) | 8.7 | | | |
| Yes | Ramp Width (in) | 121.0 | No | Ramp XSlope (%) | 3.1 | | | |

| Possible Solutions: |
|---|
| Remove & Replace Entire Ramp. |
