# Access Compliance Report

## Public Rights-of-Way

### (Curb Ramps)

| Intersection ID: 54371 | Main Street: BENSEVAL_LN | Cross Street: LONGWALL_LN | Location: E |

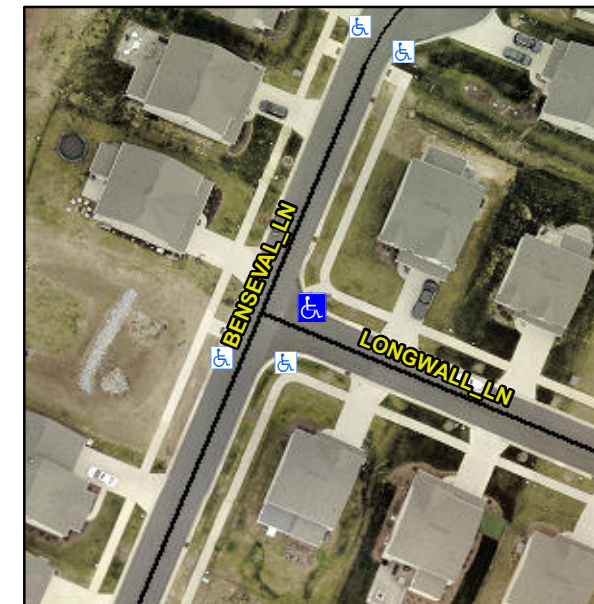
| ADA ID: 62A870FCD341 | Ramp Type: BlendTrans1 | Initial Pass/Fail: Fail | Overall Compliance: No |

**Not Found, R304.5.1**

| Compliance | Description | Data | Compliance | Description | Data |
|---|---|---|---|---|---|
| No | Ramp Width (in) | 47.5 | Yes | BlendTrans XSlope (%) | 1.7 |
| | | | No | Curb Slope (%) | 17.2 |

**Remove & Replace Curb Ramp With Two New Directional Ramps or Equivalent.**
