Access Compliance Report

Public Rights-of-Way

(Curb Ramps)

Intersection ID: 50666	Main Street: SPRINGPOINT_LN	Cross Street: SAMUEL_NEEL_RD	Location: SE
ADA ID: 62AAAF0D907D	Ramp Type: PerpDiag	Initial Pass/Fail: Fail	Overall Compliance: No
Severity Score: 50			
Codes/Mitigation Info/Possible Solution		Field Measurements/Component Compliance

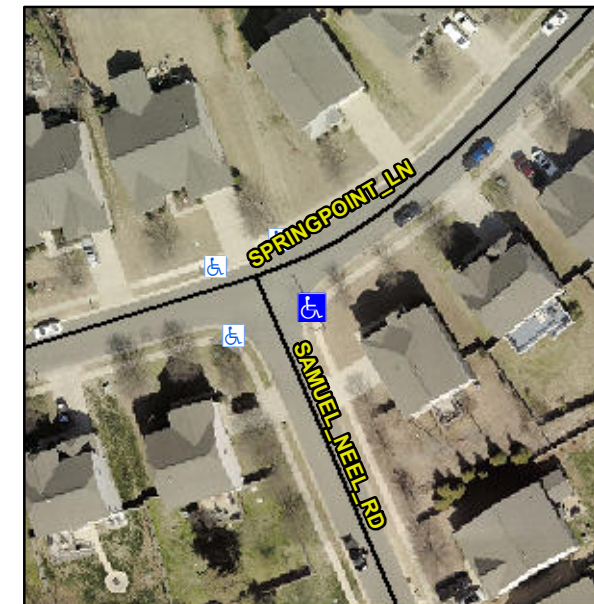
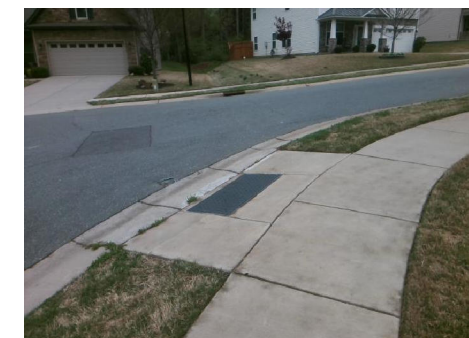
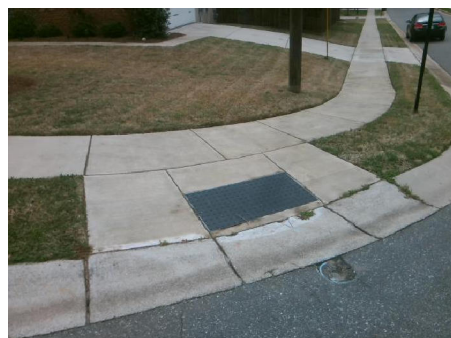
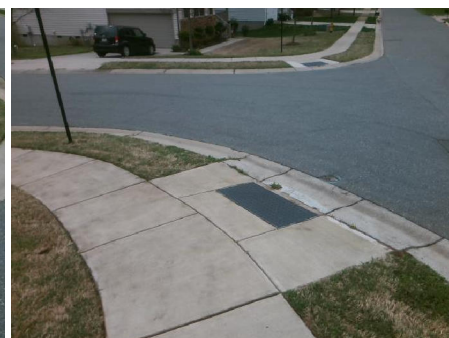
Not Found, R304.2.2, R304.5.3

Compliance	Description	Data	Compliance	Description	Data
N/A	Ramp Length (in)	48.0	No	Ramp Slope (%)	15.2
Yes	Ramp Width (in)	48.0	No	Ramp XSlope (%)	9.9
N/A	Flare Type LT	N/A	N/A	Flare Type RT	N/A
N/A	Flare Slope LT (%)	N/A	N/A	Flare Slope RT (%)	N/A
N/A	Flare Traversable LT?	N/A	N/A	Flare Traversable RT?	N/A
N/A	Landing Length (in)	N/A	N/A	DWS Provided?	N/A
N/A	Landing Width (in)	N/A	N/A	DWS Contrast?	N/A
N/A	Landing Slope (%)	N/A	N/A	DWS Length (in)	N/A
N/A	Landing X Slope (%)	N/A	N/A	DWS Full Width?	N/A
N/A	Landing Curb? (Y/N)	N/A	N/A	DWS Offset (in)	N/A
N/A	Shared Landing?	N/A			
N/A	Gutter Ponding?	N/A	N/A	Gutter Slope (%)	N/A
N/A	Gutter Lip Ht (in)	N/A	N/A	Gutter X Slope (%)	N/A
N/A	Painted X Walk1?	No	N/A	Painted X Walk2?	No
	X Walk 1 Direction	To NW		X Walk 2 Direction	To SW
N/A	X Walk 1 Width (in)	N/A	N/A	X Walk 2 Width (in)	N/A
	X Walk 1 Slope (%)	5.9		X Walk 2 Slope (%)	3.2
	X Walk 1 X Slope (%)	7.2		X Walk 2 X Slope (%)	8.3

N/A	Ramp inside XWalk1?	N/A	N/A	Ramp inside XWalk2?	N/A
	Road Slope (%)	9.1	N/A	Clear Space?	N/A
	Road X Slope (%)	1.4	N/A	Clear Space to XWalk (in)	N/A
N/A	Any Obstructions?	N/A	N/A	Storm Grate/Utility Hazard?	N/A
	Obstruction Type			Storm Grate/Utility Type	
		N/A			N/A
			Yes	Surface Condition? (G/P)	Good

Remove & Replace Curb Ramp With Two New Directional Ramps or Equivalent.
