Access Compliance Report

Public Rights-of-Way

(Curb Ramps)

Intersection ID: 3587	Main Street: SHENINGTON_PL	Cross Street: TRENTSBY_PL	Location: NW
ADA ID: 62ADD606365D	Ramp Type: Perp	Initial Pass/Fail: Fail	Overall Compliance: No
		Severity Score: 12.5

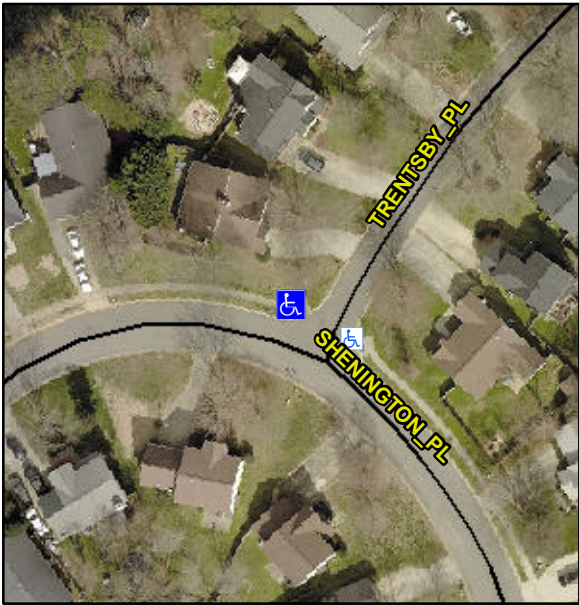
Possible Solutions:			Compliance	Description	Data	Compliance	Description	Data
	Remove & Replace Entire Ramp.			N/A	Ramp Length (in)	48.0	No	Ramp Slope (%)	11.1
				Yes	Ramp Width (in)	48.0	Yes	Ramp XSlope (%)	0.9
				N/A	Flare Type LT	N/A	N/A	Flare Type RT	N/A
				N/A	Flare Slope LT (%)	N/A	N/A	Flare Slope RT (%)	N/A
				N/A	Flare Traversable LT?	N/A	N/A	Flare Traversable RT?	N/A
				N/A	Landing Length (in)	N/A	N/A	DWS Provided?	N/A
				N/A	Landing Width (in)	N/A	N/A	DWS Contrast?	N/A
				N/A	Landing Slope (%)	N/A	N/A	DWS Length (in)	N/A
				N/A	Landing X Slope (%)	N/A	N/A	DWS Full Width?	N/A
Surveyor Notes:			N/A	Landing Curb? (Y/N)	N/A	N/A	DWS Offset (in)	N/A	N/A
PROW/ADA:			N/A	Shared Landing?	N/A				
R304.2.2			N/A	Gutter Ponding?	N/A	N/A	N/A	Gutter Slope (%)	N/A
			N/A	Gutter Lip Ht (in)	N/A	N/A	N/A	Gutter X Slope (%)	N/A

N/A	Painted X Walk1?	No	N/A	N/A	Painted X Walk2?	N/A
				X Walk 1 Direction	To SE			X Walk 2 Direction	N/A
			N/A	X Walk 1 Width (in)	N/A	N/A	N/A	X Walk 2 Width (in)	N/A
				X Walk 1 Slope (%)	2.7			X Walk 2 Slope (%)	N/A
				X Walk 1 X Slope (%)	0.4			X Walk 2 X Slope (%)	N/A
			N/A	Ramp inside XWalk1?	N/A	N/A	N/A	Ramp inside XWalk2?	N/A
				Road Slope (%)	N/A	N/A	N/A	Clear Space?	N/A
				Road X Slope (%)	N/A	N/A	N/A	Clear Space to XWalk (in)	N/A
			N/A	Any Obstructions?	N/A	N/A	N/A	Storm Grate/Utility Hazard?	N/A
				Obstruction Type				Storm Grate/Utility Type	
						N/A			N/A
							Yes	Surface Condition? (G/P)	Good
Total Cost:			\$	1850.00
