Access Compliance Report

Public Rights-of-Way

(Curb Ramps)

| Intersection ID: 45638 | Main Street: PLEASANT_PLAINS_RD | Cross Street: CALLONWOOD_DR | Location: SE |

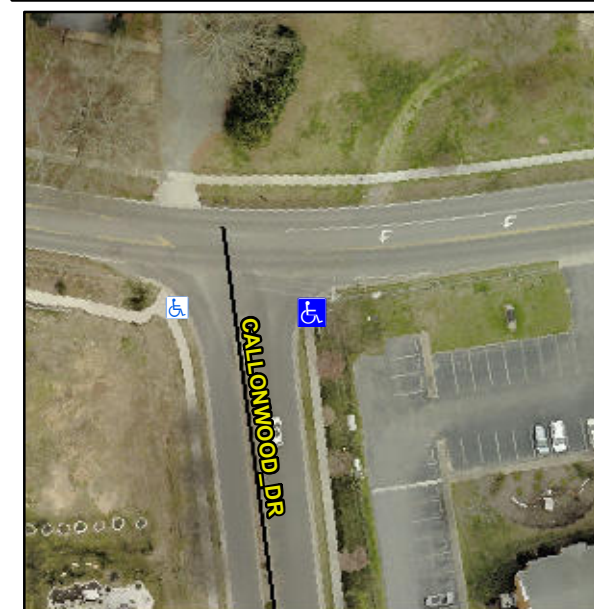
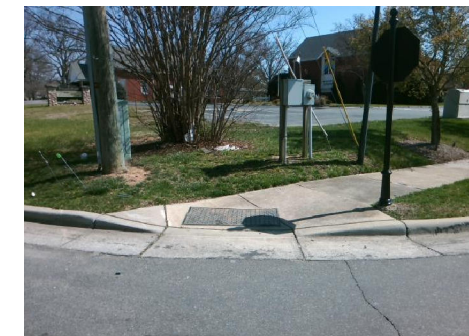
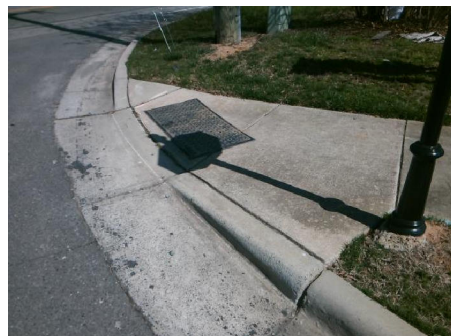
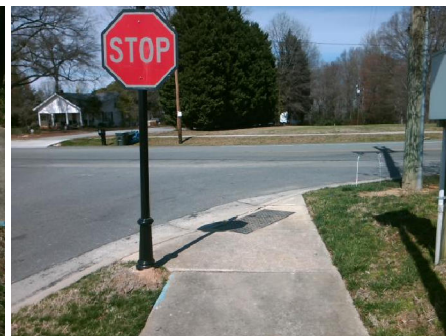
Not Found, R304.5.1, R304.5.3

| Compliance | Description | Data | Compliance | Description | Data |
|---|---|---|---|---|---|
| N/A | Ramp Length (in) | 36.5 | Yes | Ramp Slope (%) | 5.5 |
| No | Ramp Width (in) | 34.0 | No | Ramp XSlope (%) | 2.6 |

Remove & Replace Entire Ramp.
