Access Compliance Report

Public Rights-of-Way

(Curb Ramps)

Intersection ID: 31771	Main Street: STARNES RANDALL RD	Cross Street: PINYON PINE LN	Location: NW
ADA ID: 62B5C9CEFF6F	Ramp Type: Perp	Initial Pass/Fail: Fail	Overall Compliance: No
Severity Score: 22.5			
Codes/Mitigation Info/Possible Solution		Field Measurements/Component Compliance

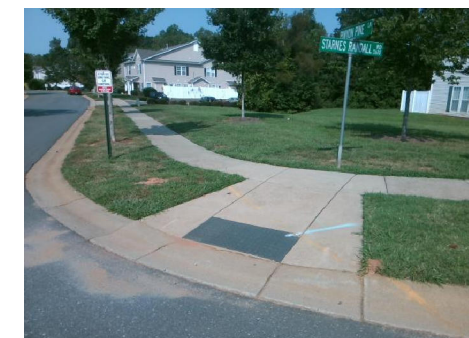
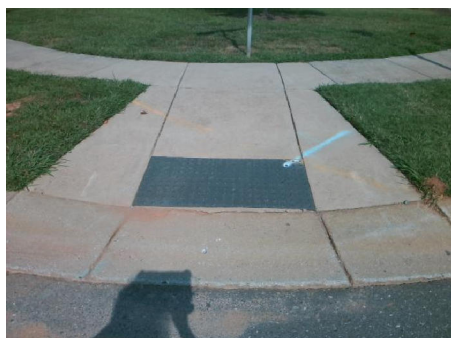
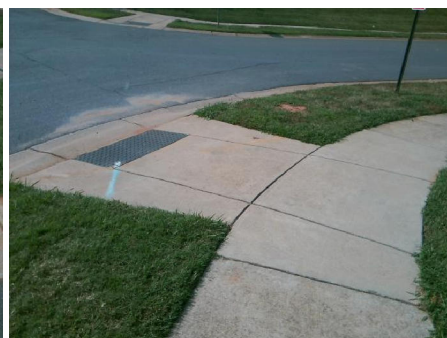
Not Found, R304.5.1, R304.2.2, R304.5.3

Compliance	Description	Data	Compliance	Description	Data
N/A	Ramp Length (in)	85.0	No	Ramp Slope (%)	8.8
No	Ramp Width (in)	47.5	No	Ramp XSlope (%)	2.3
N/A	Flare Type LT	N/A	N/A	Flare Type RT	N/A
N/A	Flare Slope LT (%)	N/A	N/A	Flare Slope RT (%)	N/A
N/A	Flare Traversable LT?	N/A	N/A	Flare Traversable RT?	N/A
N/A	Landing Length (in)	N/A	N/A	DWS Provided?	N/A
N/A	Landing Width (in)	N/A	N/A	DWS Contrast?	N/A
N/A	Landing Slope (%)	N/A	N/A	DWS Length (in)	N/A
N/A	Landing X Slope (%)	N/A	N/A	DWS Full Width?	N/A
N/A	Landing Curb? (Y/N)	N/A	N/A	DWS Offset (in)	N/A
N/A	Shared Landing?	N/A			
N/A	Gutter Ponding?	N/A	N/A	Gutter Slope (%)	N/A
N/A	Gutter Lip Ht (in)	N/A	N/A	Gutter X Slope (%)	N/A
N/A	Painted X Walk1?	No	N/A	Painted X Walk2?	N/A
	X Walk 1 Direction	To S		X Walk 2 Direction	N/A
N/A	X Walk 1 Width (in)	N/A	N/A	X Walk 2 Width (in)	N/A
	X Walk 1 Slope (%)	4.7		X Walk 2 Slope (%)	N/A
	X Walk 1 X Slope (%)	1.7		X Walk 2 X Slope (%)	N/A

N/A	Ramp inside XWalk1?	N/A	N/A	Ramp inside XWalk2?	N/A
	Road Slope (%)	N/A	N/A	Clear Space?	N/A
	Road X Slope (%)	N/A	N/A	Clear Space to XWalk (in)	N/A
N/A	Any Obstructions?	N/A	N/A	Storm Grate/Utility Hazard?	N/A
	Obstruction Type			Storm Grate/Utility Type	
		N/A			N/A
			Yes	Surface Condition? (G/P)	Good

Remove & Replace Entire Ramp.

Total Cost: \$ 1850.00
