Access Compliance Report Public Rights-of-Way (Curb Ramps)

Intersection ID: 17443 Main Street: E EXMORE ST **Cross Street: OLD PINEVILLE RD** Location: SW **ADA ID: 62BB741AEF8D** Ramp Type: PerpDiag Initial Pass/Fail: Fail **Overall Compliance: No** Severity Score: 13.75

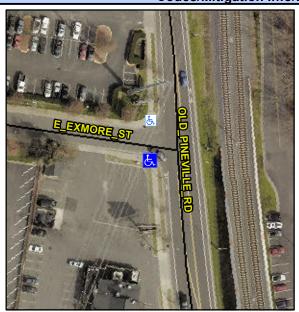
Comp	liance Description	Data	Comp	liance	Description	Data
N/A	Ramp Length (in)	76.0	No	Ramp	Slope (%)	11.1
Yes	Ramp Width (in)	48.0	No	Ramp	XSlope (%)	2.2
N/A	Flare Type LT	N/A	N/A	Flare	Type RT	N/A
N/A	Flare Slope LT (%)	N/A	N/A	Flare	Slope RT (%)	N/A
N/A	Flare Traversable LT?	N/A	N/A	Flare	Traversable RT?	N/A
N/A	Landing Length (in)	N/A	N/A	DWS	Provided?	N/A
N/A	Landing Width (in)	N/A	N/A	DWS	Contrast?	N/A
N/A	Landing Slope (%)	N/A	N/A	DWS	Length (in)	N/A
N/A	Landing X Slope (%)	N/A	N/A	DWS	Full Width?	N/A
N/A	Landing Curb? (Y/N)	N/A	N/A	DWS	Offset (in)	N/A
N/A	Shared Landing?	N/A				
N/A	Gutter Ponding?	N/A	N/A	Gutte	er Slope (%)	N/A
N/A	Gutter Lip Ht (in)	N/A	N/A	Gutte	r X Slope (%)	N/A
N/A	Painted X Walk1?	No	N/A	Paint	ed X Walk2?	No
	X Walk 1 Direction	To E		X Wa	lk 2 Direction	To N
N/A	X Walk 1 Width (in)	N/A	N/A	X Wa	lk 2 Width (in)	N/A
	X Walk 1 Slope (%)	2.9		X Wa	lk 2 Slope (%)	6.3
	X Walk 1 X Slope (%)	2.6		X Wa	lk 2 X Slope (%)	2.

N/A	Ramp inside XWalk1?	N/A	N/A	Ramp	inside XWalk2?	N/A
	Road Slope (%)	2.0	N/A	Clear	Space?	N/A
	Road X Slope (%)	8.0	N/A	Clear	Space to XWalk (in)	N/A
N/A	Any Obstructions?	N/A	N/A	Storm	n Grate/Utility Hazard?	N/A
	Obstruction Type		l	Storm	n Grate/Utility Type	
		N/A				N/A
			Yes	Surfa	ce Condition? (G/P)	Good

Possible Solutions: **Remove & Replace Curb Ramp With Two New Directional Ramps or** Equivalent. Surveyor Notes: N/A PROW/ADA: Not Found, R304.2.2, R304.5.3
