Access Compliance Report

Public Rights-of-Way

(Curb Ramps)

Intersection ID: 7762	Main Street: N_GRAHAM_ST	Cross Street: W_CRAIGHEAD_RD	Location: SE
ADA ID: 62BE2A226E9B	Ramp Type: Para	Initial Pass/Fail: Fail	Overall Compliance: No
Codes/Mitigation Info/Possible Solution		Field Measurements/Component Compliance	
Severity Score: 13.75

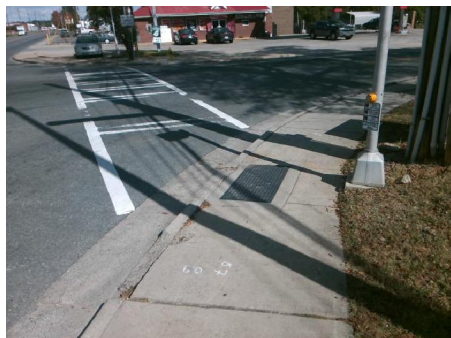
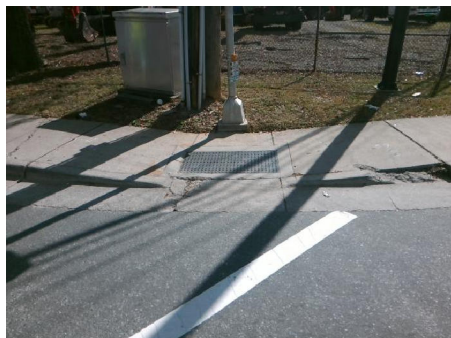
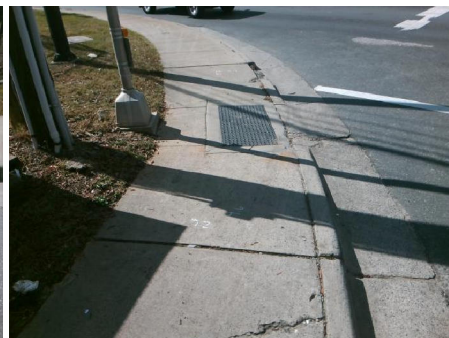
DAMAGED CURB, LT RP < 5%

Compliance	Description	Data	Compliance	Description	Data
N/A	Ramp Length LT (in)	62.0	N/A	Ramp Length RT (in)	66.5
Yes	Ramp Width LT (in)	59.5	Yes	Ramp Width RT (in)	59.5
Yes	Ramp Slope LT (%)	4.6	No	Ramp Slope RT (%)	8.7
No	Ramp XSlope LT (%)	2.6	Yes	Ramp XSlope RT (%)	0.9
N/A	Landing Length (in)	N/A	N/A	DWS Provided?	N/A
N/A	Landing Width (in)	N/A	N/A	DWS Contrast?	N/A
N/A	Landing Slope (%)	N/A	N/A	DWS Length (in)	N/A
N/A	Landing X Slope (%)	N/A	N/A	DWS Full Width?	N/A
N/A	Landing Curb? (Y/N)	N/A	N/A	DWS Offset (in)	N/A
N/A	Shared Landing?	N/A			
N/A	Gutter Ponding?	N/A	N/A	Gutter Slope (%)	N/A
N/A	Gutter Lip Ht (in)	N/A	N/A	Gutter X Slope (%)	N/A
N/A	Painted X Walk1?	Yes	N/A	Painted X Walk2?	N/A
	X Walk 1 Direction	To NE		X Walk 2 Direction	N/A
N/A	X Walk 1 Width (in)	103.5	N/A	X Walk 2 Width (in)	N/A
	X Walk 1 Slope (%)	0.5		X Walk 2 Slope (%)	N/A
	X Walk 1 X Slope (%)	4.6		X Walk 2 X Slope (%)	N/A
N/A	Ramp inside XWalk1?	Yes	N/A	Ramp inside XWalk2?	N/A

Road Slope (%)	N/A	N/A	Clear Space?	N/A
	Road X Slope (%)	N/A	N/A	Clear Space to XWalk (in)	N/A
N/A	Any Obstructions?	N/A	N/A	Storm Grate/Utility Hazard?	N/A
	Obstruction Type			Storm Grate/Utility Type	
		N/A			N/A
			Yes	Surface Condition? (G/P)	Good
			N/A	Curb Slope (%)	18.0

Possible Solutions:

Remove & Replace Entire Ramp.
