# Access Compliance Report

## Public Rights-of-Way

### (Curb Ramps)

Intersection ID: N/A	Main Street: NORTH_COMMUNITY_HOUSE_RD	Cross Street: COMMUNITY_COMMONS_RD	Location: SE
ADA ID: 62D1A5A733EC	Ramp Type: Directional	Initial Pass/Fail: Fail	Overall Compliance: No
Codes/Mitigation Info/Possible Solution		Field Measurements/Component Compliance	
Severity Score: 1.25

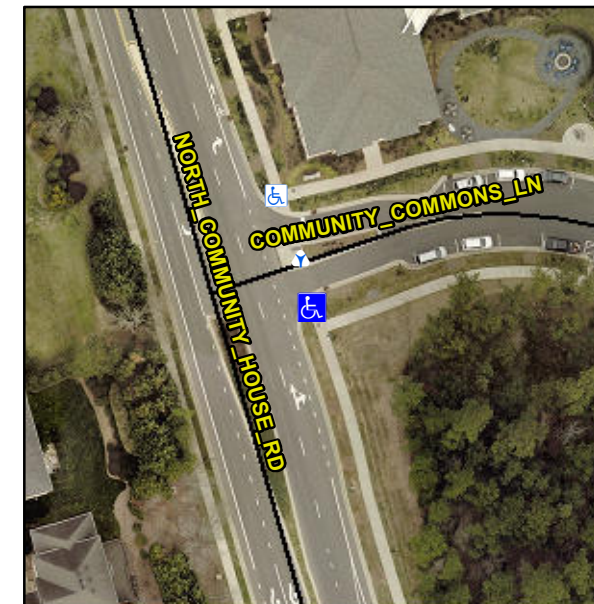
**R304.5.3**

Compliance	Description	Data	Compliance	Description	Data
N/A	Ramp Length (in)	132.0	N/A	Grade Break?	N/A
Yes	Ramp Width (in)	67.0	N/A	Grade Break Slope (%)	0.0
Yes	Ramp Slope (%)	6.4	N/A	Grade Break XSlope (%)	0.0
No	Ramp XSlope (%)	2.1			
N/A	Flare Type LT	N/A	N/A	Flare Type RT	N/A
N/A	Flare Slope LT (%)	N/A	N/A	Flare Slope RT (%)	0.0
N/A	Flare Traversable LT?	N/A	N/A	Flare Traversable RT?	N/A
N/A	Landing Length (in)	0.0	N/A	DWS Provided?	N/A
N/A	Landing Width (in)	0.0	N/A	DWS Contrast?	N/A
N/A	Landing Slope (%)	0.0	N/A	DWS Length (in)	N/A
N/A	Landing X Slope (%)	0.0	N/A	DWS Full Width?	N/A
N/A	Landing Curb? (Y/N)	N/A	N/A	DWS Offset LT (in)	N/A
N/A	Shared Landing?	N/A	N/A	DWS Offset RT (in)	N/A
N/A	Gutter Ponding?	0.0	N/A	Gutter Slope (%)	N/A
N/A	Gutter Lip Ht (in)	0.0	N/A	Gutter X Slope (%)	N/A
N/A	Painted X Walk1?	No		Road Slope (%)	1.5
	X Walk 1 Direction	To NW		Road X Slope (%)	1.3
	X Walk 1 Width (in)	N/A		Clear Space?	N/A

X Walk 1 Slope (%)	1.5	N/A	Clear Space to XWalk (in)	N/A
	X Walk 1 X Slope (%)	1.3	N/A	Storm Grate/Utility Hazard?	N/A
N/A	Ramp inside XWalk1?	N/A		Storm Grate/Utility Type	
N/A	Any Obstructions?	N/A			N/A
	Obstruction Type		Yes	Surface Condition? (G/P)	Good
			N/A	Curb Slope (%)	10.7

**Remove & Replace Entire Ramp.**
