# Access Compliance Report

## Public Rights-of-Way

Intersection ID: 47775	Main Street: BEREWICK COMMONS PKY	Cross Street: TRAILMOOR RD	Location: SE
ADA ID: 62E97D749B6A	Ramp Type: PerpDiag	Initial Pass/Fail: Fail	Overall Compliance: No
Severity Score: 22.5			
Codes/Mitigation Info/Possible Solution		Field Measurements/Component Compliance

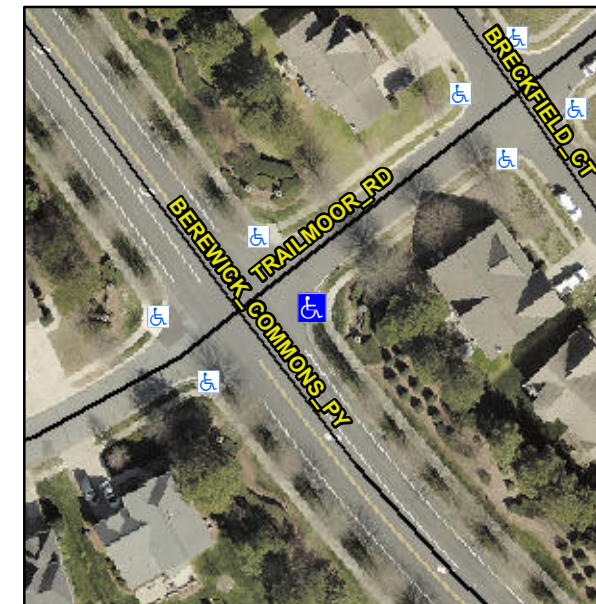
**Not Found, R304.5.1, R304.2.2, R304.5.3**

Compliance	Description	Data	Compliance	Description	Data
N/A	Ramp Length (in)	66.0	No	Ramp Slope (%)	8.6
No	Ramp Width (in)	47.0	No	Ramp XSlope (%)	3.5
N/A	Flare Type LT	N/A	N/A	Flare Type RT	N/A
N/A	Flare Slope LT (%)	N/A	N/A	Flare Slope RT (%)	N/A
N/A	Flare Traversable LT?	N/A	N/A	Flare Traversable RT?	N/A
N/A	Landing Length (in)	N/A	N/A	DWS Provided?	N/A
N/A	Landing Width (in)	N/A	N/A	DWS Contrast?	N/A
N/A	Landing Slope (%)	N/A	N/A	DWS Length (in)	N/A
N/A	Landing X Slope (%)	N/A	N/A	DWS Full Width?	N/A
N/A	Landing Curb? (Y/N)	N/A	N/A	DWS Offset (in)	N/A
N/A	Shared Landing?	N/A			
N/A	Gutter Ponding?	N/A	N/A	Gutter Slope (%)	N/A
N/A	Gutter Lip Ht (in)	N/A	N/A	Gutter X Slope (%)	N/A
N/A	Painted X Walk1?	No	N/A	Painted X Walk2?	No
	X Walk 1 Direction	To NW		X Walk 2 Direction	To SW
N/A	X Walk 1 Width (in)	N/A	N/A	X Walk 2 Width (in)	N/A
	X Walk 1 Slope (%)	4.6		X Walk 2 Slope (%)	0.4
	X Walk 1 X Slope (%)	1.7		X Walk 2 X Slope (%)	3.0

N/A	Ramp inside XWalk1?	N/A	N/A	Ramp inside XWalk2?	N/A
	Road Slope (%)	2.9	N/A	Clear Space?	N/A
	Road X Slope (%)	2.7	N/A	Clear Space to XWalk (in)	N/A
N/A	Any Obstructions?	N/A	N/A	Storm Grate/Utility Hazard?	N/A
	Obstruction Type			Storm Grate/Utility Type	
		N/A			N/A
			Yes	Surface Condition? (G/P)	Good

**Remove & Replace Curb Ramp With Two New Directional Ramps or Equivalent.**

Total Cost: \$ 3200.00
