# Access Compliance Report

## Public Rights-of-Way

| Intersection ID: 49137 | Main Street: LESTER_HILL_CT | Cross Street: POPE_FARM_RD | Location: SW |
| ADA ID: 62F3DEA424B8 | Ramp Type: PerpDiag | Initial Pass/Fail: Fail | Overall Compliance: No |

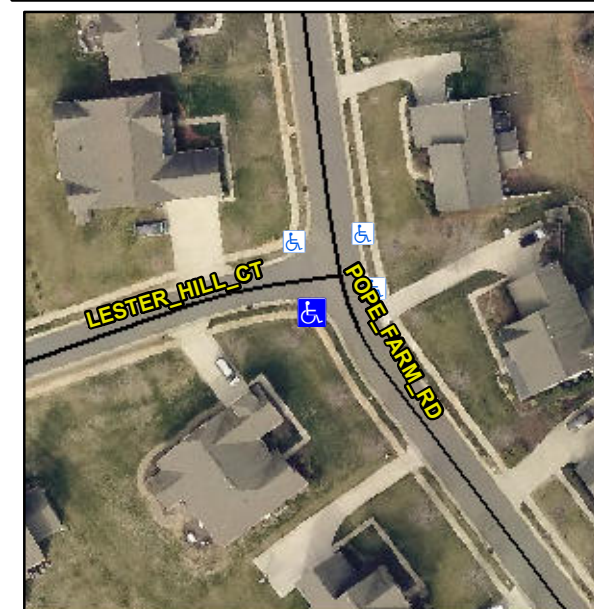
| Severity Score: 13.75 | | | |

**Not Found, R304.2.2, R304.5.3**

| Compliance | Description | Data | Compliance | Description | Data |
|---|---|---|---|---|---|
| N/A | Ramp Length (in) | 48.0 | No | Ramp Slope (%) | 9.4 |
| Yes | Ramp Width (in) | 48.0 | No | Ramp XSlope (%) | 3.3 |

**Remove & Replace Curb Ramp With Two New Directional Ramps or Equivalent.**

Total Cost: \$ 3200.00
