Access Compliance Report

Public Rights-of-Way

(Curb Ramps)

Intersection ID: 19029	Main Street: SHARON_LN	Cross Street: FOXCROFT_RD	Location: SW
ADA ID: 6301F9768C10	Ramp Type: ParaDiag	Initial Pass/Fail: Fail	Overall Compliance: No
Codes/Mitigation Info/Possible Solution		Field Measurements/Component Compliance	
Severity Score: 26.25

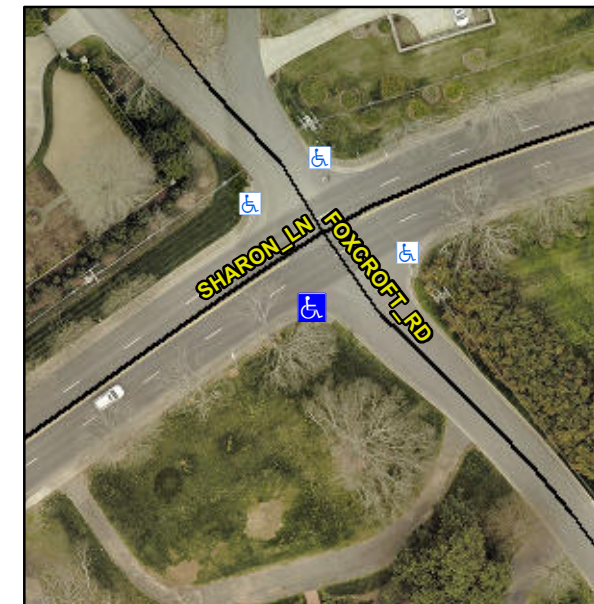
LT RP < 5%

PROW/ADA:

R304.3.2, R304.5.3

Compliance	Description	Data	Compliance	Description	Data
N/A	Ramp Length LT (in)	56.0	N/A	Ramp Length RT (in)	40.0
Yes	Ramp Width LT (in)	51.0	Yes	Ramp Width RT (in)	51.0
Yes	Ramp Slope LT (%)	0.4	No	Ramp Slope RT (%)	12.4
Yes	Ramp XSlope LT (%)	1.5	No	Ramp XSlope RT (%)	4.1
N/A	Landing Length (in)	N/A	N/A	DWS Provided?	N/A
N/A	Landing Width (in)	N/A	N/A	DWS Contrast?	N/A
N/A	Landing Slope (%)	N/A	N/A	DWS Length (in)	N/A
N/A	Landing X Slope (%)	N/A	N/A	DWS Full Width?	N/A
N/A	Landing Curb? (Y/N)	N/A	N/A	DWS Offset (in)	N/A
N/A	Shared Landing?	N/A			
N/A	Gutter Ponding?	N/A	N/A	Gutter Slope (%)	N/A
N/A	Gutter Lip Ht (in)	N/A	N/A	Gutter X Slope (%)	N/A
N/A	Painted X Walk1?	No	N/A	Painted X Walk2?	No
	X Walk 1 Direction	To NE		X Walk 2 Direction	To NW
N/A	X Walk 1 Width (in)	N/A	N/A	X Walk 2 Width (in)	N/A
	X Walk 1 Slope (%)	4.7		X Walk 2 Slope (%)	8.8
	X Walk 1 X Slope (%)	6.4		X Walk 2 X Slope (%)	1.1
N/A	Ramp inside XWalk1?	N/A	N/A	Ramp inside XWalk2?	N/A

Road Slope (%)	4.7	N/A	Clear Space?	N/A
	Road X Slope (%)	6.6	N/A	Clear Space to XWalk (in)	N/A
N/A	Any Obstructions?	N/A	N/A	Storm Grate/Utility Hazard?	N/A
	Obstruction Type			Storm Grate/Utility Type	
		N/A			N/A
			Yes	Surface Condition? (G/P)	Good
			N/A	Curb Slope (%)	7.4

Possible Solutions:

Remove & Replace Curb Ramp With Two New Directional Ramps or Equivalent.
