Access Compliance Report

Public Rights-of-Way (Curb Ramps)

Intersection ID: N/A	Main Street: ARBOR_LOOP_DR	Cross Street: POTOMAC_RIVER_PY	Location: NE
ADA ID: 630F2F224097	Ramp Type: Directional1	Initial Pass/Fail: Fail	Overall Compliance: No
		Severity Score: 1.25

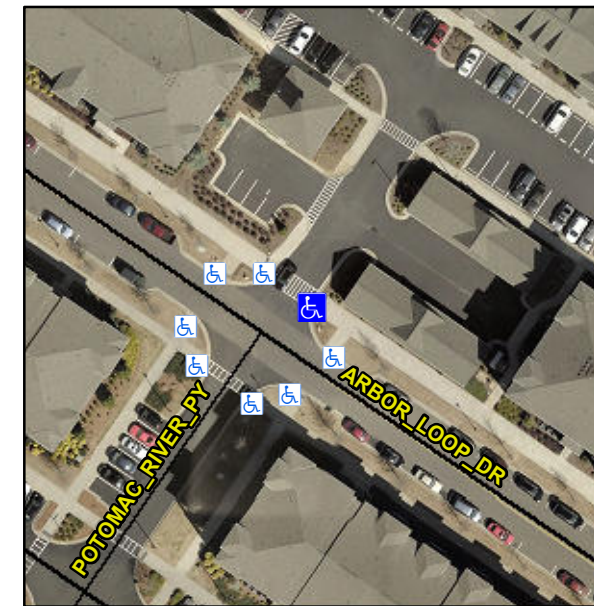
R304.5.3

Compliance	Description	Data	Compliance	Description	Data
N/A	Ramp Length (in)	71.0	N/A	Grade Break?	N/A
Yes	Ramp Width (in)	118.0	N/A	Grade Break Slope (%)	0.0
Yes	Ramp Slope (%)	2.5	N/A	Grade Break XSlope (%)	0.0
No	Ramp XSlope (%)	2.2			
N/A	Flare Type LT	N/A	N/A	Flare Type RT	N/A
N/A	Flare Slope LT (%)	N/A	N/A	Flare Slope RT (%)	0.0
N/A	Flare Traversable LT?	N/A	N/A	Flare Traversable RT?	N/A
N/A	Landing Length (in)	0.0	N/A	DWS Provided?	N/A
N/A	Landing Width (in)	0.0	N/A	DWS Contrast?	N/A
N/A	Landing Slope (%)	0.0	N/A	DWS Length (in)	N/A
N/A	Landing X Slope (%)	0.0	N/A	DWS Full Width?	N/A
N/A	Landing Curb? (Y/N)	N/A	N/A	DWS Offset LT (in)	N/A
N/A	Shared Landing?	N/A	N/A	DWS Offset RT (in)	N/A
N/A	Gutter Ponding?	0.0	N/A	Gutter Slope (%)	N/A
N/A	Gutter Lip Ht (in)	0.0	N/A	Gutter X Slope (%)	N/A
N/A	Painted X Walk1?	Yes		Road Slope (%)	0.3
	X Walk 1 Direction	To W		Road X Slope (%)	2.5
	X Walk 1 Width (in)	118.0		Clear Space?	N/A

X Walk 1 Slope (%)	0.3	N/A	Clear Space to XWalk (in)	N/A
	X Walk 1 X Slope (%)	2.5	N/A	Storm Grate/Utility Hazard?	N/A
N/A	Ramp inside XWalk1?	Yes		Storm Grate/Utility Type	
N/A	Any Obstructions?	N/A			N/A
	Obstruction Type		Yes	Surface Condition? (G/P)	Good
			N/A	Curb Slope (%)	6.0

Remove & Replace Entire Ramp.

Total Cost: \$ 1600.00
