Access Compliance Report Public Rights-of-Way (Curb Ramps)

Intersection ID: 9735	Main Street: TINNIN_AV			Street:	GENESIS_PARK_PL	Location:	NW		
ADA ID: 63420C6687CF	Ramp Type: Perp			Initial Pass/Fail: Fail Overall Compliance: No				o Severity Score:	35
Codes/Mitigation Info/Possible Solution				Field Measurements/Component Compliance					
	1 A. 1	Possible Solutions:		Compliance Description Data Compliance				liance Description	Data
	Uper	Remove & Replace Entire Ramp).	N/A	Ramp Length (in)	63.0	No	Ramp Slope (%)	13.3
		4		No	Ramp Width (in)	41.0	No	Ramp XSlope (%)	3.4
	ment and			N/A	Flare Type LT	N/A	N/A	Flare Type RT	N/A
		2		N/A	Flare Slope LT (%)	N/A	N/A	Flare Slope RT (%)	N/A
				N/A	Flare Traversable LT?	N/A	N/A	Flare Traversable RT?	N/A
				N/A	Landing Length (in)	N/A	N/A	DWS Provided?	N/A
		Surveyor Notes:		N/A	Landing Width (in)	N/A	N/A	DWS Contrast?	N/A
	Le 1	N/A		N/A	Landing Slope (%)	N/A	N/A	DWS Length (in)	N/A
	The a			N/A	Landing X Slope (%)	N/A	N/A	DWS Full Width?	N/A

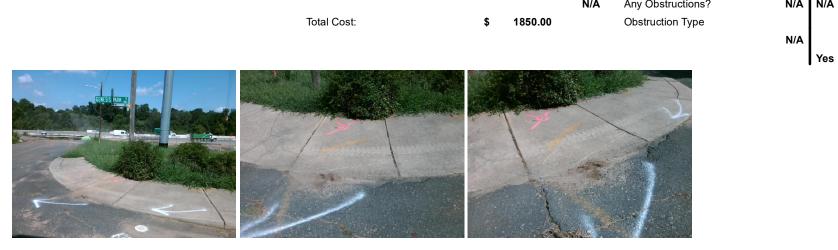
es Surface Condition? (G/P)

Good

6	ton ?			N/A	Landing Curb? (Y/N)	N/A	N/A	DWS Offset (in)	N/A
	A Martin			N/A	Shared Landing?	N/A			
		PROW/ADA:		N/A	Gutter Ponding?	N/A	N/A	Gutter Slope (%)	N/A
		R304.5.1, R304.2.2, R304.5.3		N/A	Gutter Lip Ht (in)	N/A	N/A	Gutter X Slope (%)	N/A
		· · · · · · · · · · · · · · · · · · ·		N/A	Painted X Walk1?	No	N/A	Painted X Walk2?	N/A
				X Walk 1 Direction	To SE		X Walk 2 Direction	N/A	
			N/A	X Walk 1 Width (in)	N/A	N/A	X Walk 2 Width (in)	N/A	
Street 1 Name	TINNIN AV	_			X Walk 1 Slope (%)	2.3		X Walk 2 Slope (%)	N/A
Stop Condition-Street 2	StopSign				X Walk 1 X Slope (%)	2.9		X Walk 2 X Slope (%)	N/A
Street 2 Name	N/A			N/A	Ramp inside XWalk1?	N/A	N/A	Ramp inside XWalk2?	N/A
Stop Condition-Street 1	N/A				Road Slope (%)	N/A	N/A	Clear Space?	N/A
					Road X Slope (%)	N/A	N/A	Clear Space to XWalk (in)	N/A
				N/A	Any Obstructions?	N/A	N/A	Storm Grate/Utility Hazard?	N/A
		Total Cost: \$	1850.00		Obstruction Type			Storm Grate/Utility Type
