Access Compliance Report

Public Rights-of-Way

(Curb Ramps)

Intersection ID: N/A	Main Street: OLD_CONCORD_RD	Cross Street: ORCHID_BRIDGE_RD	Location: SE
ADA ID: 634412846A45	Ramp Type: Perp	Initial Pass/Fail: Fail	Overall Compliance: No
		Severity Score: 25

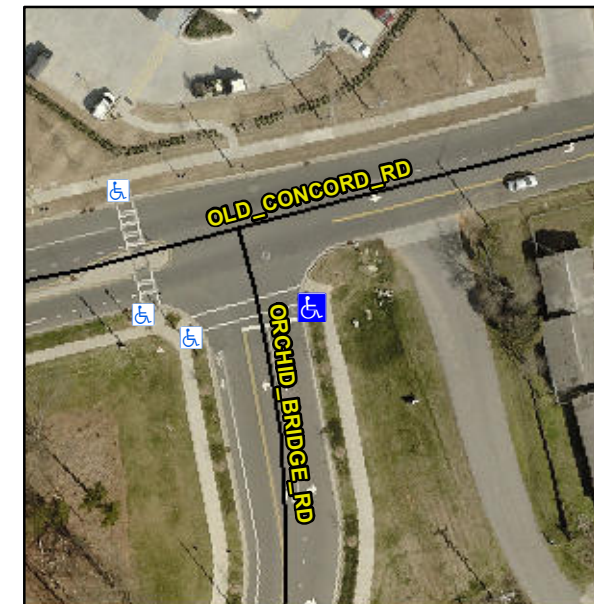
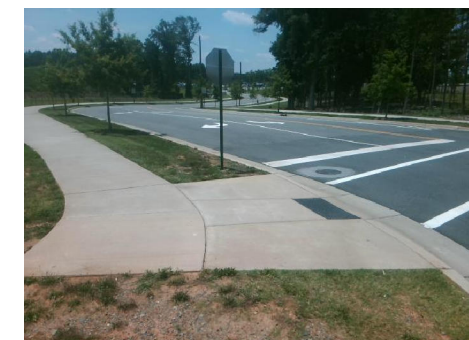
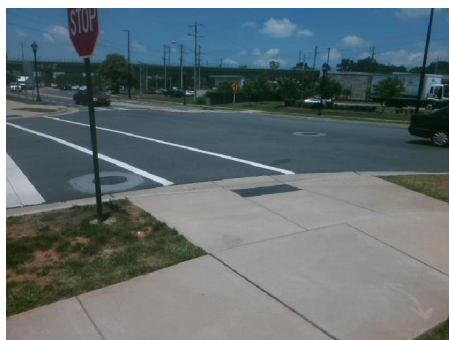
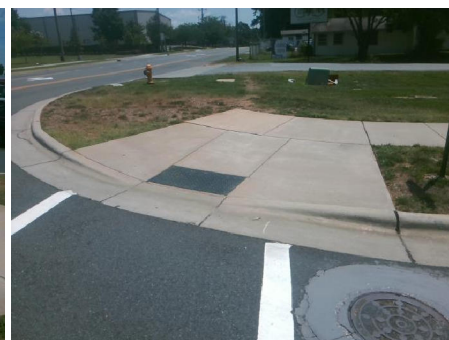
R304.5.3

Compliance	Description	Data	Compliance	Description	Data
N/A	Ramp Length (in)	97.0	Yes	Ramp Slope (%)	7.6
Yes	Ramp Width (in)	48.0	No	Ramp XSlope (%)	7.1
N/A	Flare Type LT	N/A	N/A	Flare Type RT	N/A
N/A	Flare Slope LT (%)	N/A	N/A	Flare Slope RT (%)	N/A
N/A	Flare Traversable LT?	N/A	N/A	Flare Traversable RT?	N/A
N/A	Landing Length (in)	N/A	N/A	DWS Provided?	N/A
N/A	Landing Width (in)	N/A	N/A	DWS Contrast?	N/A
N/A	Landing Slope (%)	N/A	N/A	DWS Length (in)	N/A
N/A	Landing X Slope (%)	N/A	N/A	DWS Full Width?	N/A
N/A	Landing Curb? (Y/N)	N/A	N/A	DWS Offset (in)	N/A
N/A	Shared Landing?	N/A			
N/A	Gutter Ponding?	N/A	N/A	Gutter Slope (%)	N/A
N/A	Gutter Lip Ht (in)	N/A	N/A	Gutter X Slope (%)	N/A
N/A	Painted X Walk1?	Yes	N/A	Painted X Walk2?	N/A
	X Walk 1 Direction	To W		X Walk 2 Direction	N/A
N/A	X Walk 1 Width (in)	92.0	N/A	X Walk 2 Width (in)	N/A
	X Walk 1 Slope (%)	2.4		X Walk 2 Slope (%)	N/A
	X Walk 1 X Slope (%)	4.1		X Walk 2 X Slope (%)	N/A

N/A	Ramp inside XWalk1?	Yes	N/A	Ramp inside XWalk2?	N/A
	Road Slope (%)	N/A	N/A	Clear Space?	N/A
	Road X Slope (%)	N/A	N/A	Clear Space to XWalk (in)	N/A
N/A	Any Obstructions?	N/A	N/A	Storm Grate/Utility Hazard?	N/A
	Obstruction Type			Storm Grate/Utility Type	
		N/A			N/A
		Yes		Surface Condition? (G/P)	Good

Remove & Replace Entire Ramp.

\$ 1850.00
