Intersection ID: 12046	Main Street: S_CEDAR_ST	Cross Street: W_1ST_ST	Location:	W
ADA ID: 634A84B532C2	Ramp Type: Perp	Initial Pass/Fail: Fail	Overall Compliance: No	Severity Score: 1.25

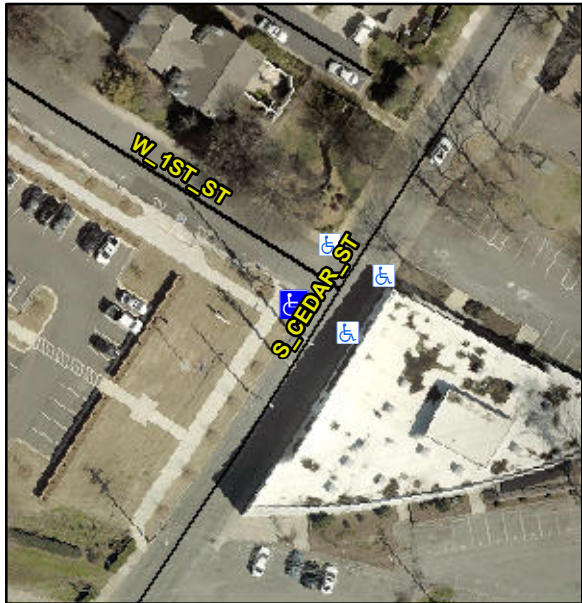
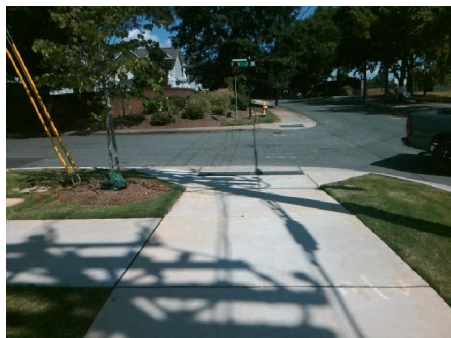
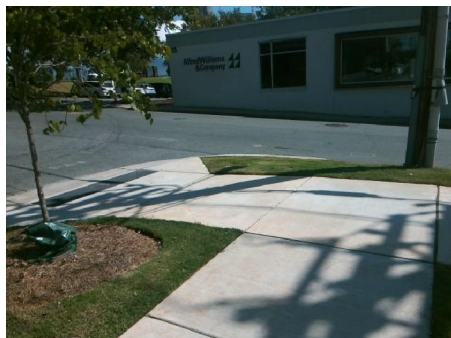
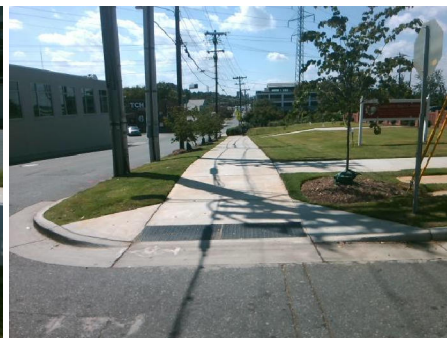
Possible Solutions:		Compliance	Description	Data	Compliance	Description	Data
	Remove & Replace Entire Ramp.		N/A	Ramp Length (in)	153.0	Yes	Ramp Slope (%)	5.1
			Yes	Ramp Width (in)	97.0	No	Ramp XSlope (%)	2.3
			N/A	Flare Type LT	N/A	N/A	Flare Type RT	N/A
			N/A	Flare Slope LT (%)	N/A	N/A	Flare Slope RT (%)	N/A
			N/A	Flare Traversable LT?	N/A	N/A	Flare Traversable RT?	N/A
			N/A	Landing Length (in)	N/A	N/A	DWS Provided?	N/A
Surveyor Notes:			N/A	Landing Width (in)	N/A	N/A	DWS Contrast?	N/A
N/A			N/A	Landing Slope (%)	N/A	N/A	DWS Length (in)	N/A
			N/A	Landing X Slope (%)	N/A	N/A	DWS Full Width?	N/A
			N/A	Landing Curb? (Y/N)	N/A	N/A	DWS Offset (in)	N/A
			N/A	Shared Landing?	N/A			
PROW/ADA:			N/A	Gutter Ponding?	N/A	N/A	Gutter Slope (%)	N/A
Not Found, R304.5.3			N/A	Gutter Lip Ht (in)	N/A	N/A	Gutter X Slope (%)	N/A

N/A	Painted X Walk1?	No	N/A	Painted X Walk2?	N/A
				X Walk 1 Direction	To NE		X Walk 2 Direction	N/A
			N/A	X Walk 1 Width (in)	N/A	N/A	X Walk 2 Width (in)	N/A
				X Walk 1 Slope (%)	6.4		X Walk 2 Slope (%)	N/A
				X Walk 1 X Slope (%)	3.4		X Walk 2 X Slope (%)	N/A
			N/A	Ramp inside XWalk1?	N/A	N/A	Ramp inside XWalk2?	N/A
				Road Slope (%)	N/A	N/A	Clear Space?	N/A
				Road X Slope (%)	N/A	N/A	Clear Space to XWalk (in)	N/A
			N/A	Any Obstructions?	N/A	N/A	Storm Grate/Utility Hazard?	N/A
				Obstruction Type			Storm Grate/Utility Type	
Total Cost:	\$	1850.00			N/A			N/A
						Yes	Surface Condition? (G/P)	Good
