Access Compliance Report

Public Rights-of-Way

(Curb Ramps)

Intersection ID: 48417	Main Street: WINDS_CROSSING_DR	Cross Street: CAROWINDS_BV	Location: SW
ADA ID: 63529E243BA7	Ramp Type: PerpDiag	Initial Pass/Fail: Fail	Overall Compliance: No
Codes/Mitigation Info/Possible Solution		Field Measurements/Component Compliance

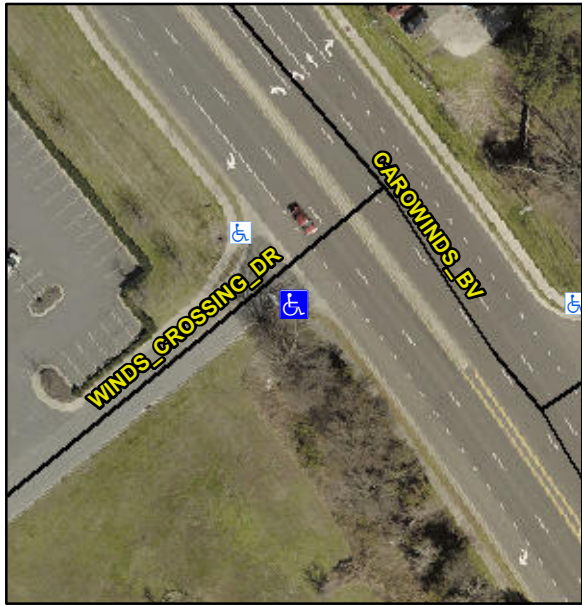
N/A		N/A		X Walk 2 Width (in)		N/A	
				2.4		X Walk 2 Slope (%)		1.4	
				1.2		X Walk 2 X Slope (%)		6.5	
		N/A		N/A		Ramp inside XWalk2?		N/A	
				3.8		Clear Space?		N/A

3.4		Clear Space to XWalk (in)		N/A	
		N/A		N/A		Storm Grate/Utility Hazard?		N/A	
				N/A		Storm Grate/Utility Type			
				N/A				N/A	
				Yes		Surface Condition? (G/P)		Good	
Total Cost:		\$ 3200.00

Possible Solutions:								
	Remove & Replace Curb Ramp With Two New Directional Ramps or Equivalent.								
	Surveyor Notes:								
	N/A								
	PROW/ADA:								
	Not Found, R304.5.1, R304.2.2, R304.5.3								
	Street 1 Name		CAROWINDS BV		Compliance		Description		Data
	Stop Condition-Street 2		None		N/A		Ramp Length (in)		48.0
	Street 2 Name		WINDS CROSSING DR		No		Ramp Width (in)		47.0
	Stop Condition-Street 1		StopSign		N/A		Flare Type LT		N/A
				N/A		Flare Slope LT (%)		N/A	
				N/A		Flare Type RT		N/A	
				N/A		Flare Slope RT (%)		N/A	
				N/A		Flare Traversable LT?		N/A	
				N/A		Flare Traversable RT?		N/A	
				N/A		DWS Provided?		N/A	
				N/A		DWS Contrast?		N/A	
				N/A		DWS Length (in)		N/A	
				N/A		DWS Full Width?		N/A	
				N/A		DWS Offset (in)		N/A	
				N/A		Shared Landing?		N/A	
				N/A		Gutter Ponding?		N/A	
				N/A		Gutter Lip Ht (in)		N/A	
				N/A		Painted X Walk1?		No	
				To E		X Walk 2 Direction		To NW
