# Access Compliance Report

## Public Rights-of-Way

### (Curb Ramps)

Intersection ID: 11058	Main Street: N I-77 EXIT 10B RA	Cross Street: N I-77 EXIT 10C RA	Location: N
ADA ID: 636AF378206A	Ramp Type: BlendTrans1	Initial Pass/Fail: Fail	Overall Compliance: No
		Severity Score: 8.75

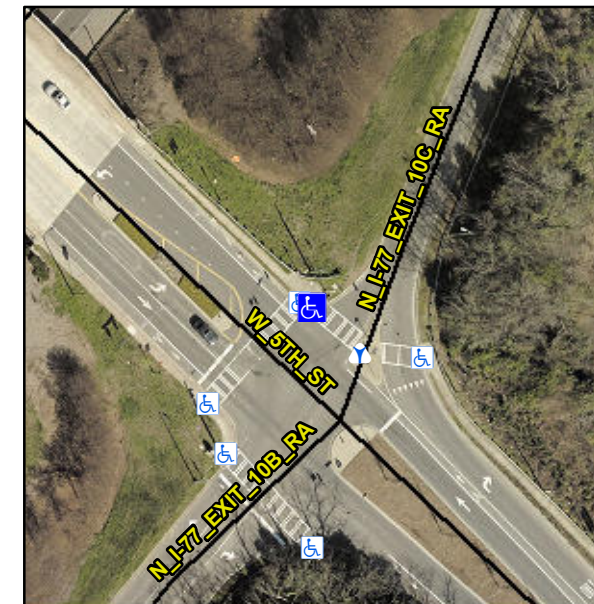
**Not Found, R304.5.1**

Compliance	Description	Data	Compliance	Description	Data
N/A	Ramp Length (in)	75.0	Yes	BlendTrans Slope (%)	4.3
No	Ramp Width (in)	46.5	Yes	BlendTrans XSlope (%)	0.3
N/A	Flare Type LT	N/A	N/A	Flare Type RT	N/A
N/A	Flare Slope LT (%)	N/A	N/A	Flare Slope RT (%)	N/A
N/A	Flare Traversable LT?	N/A	N/A	Flare Traversable RT?	N/A
N/A	Landing Length (in)	N/A	N/A	DWS Provided?	N/A
N/A	Landing Width (in)	N/A	N/A	DWS Contrast?	N/A
N/A	Landing Slope (%)	N/A	N/A	DWS Length (in)	N/A
N/A	Landing X Slope (%)	N/A	N/A	DWS Full Width?	N/A
N/A	Landing Curb? (Y/N)	N/A	N/A	DWS Offset (in)	N/A
N/A	Shared Landing?	N/A			
N/A	Gutter Ponding?	N/A	N/A	Gutter Slope (%)	N/A
N/A	Gutter Lip Ht (in)	N/A	N/A	Gutter X Slope (%)	N/A
N/A	Painted X Walk1?	Yes	N/A	Painted X Walk2?	N/A
	X Walk 1 Direction	To SE		X Walk 2 Direction	N/A
	X Walk 1 Width (in)	115.0		X Walk 2 Width (in)	N/A
	X Walk 1 Slope (%)	0.0		X Walk 2 Slope (%)	N/A
	X Walk 1 X Slope (%)	2.7		X Walk 2 X Slope (%)	N/A

N/A	Ramp inside XWalk1?	Yes	N/A	Ramp inside XWalk2?	N/A
	Road Slope (%)	2.7		Clear Space?	N/A
	Road X Slope (%)	0.0	N/A	Clear Space to XWalk (in)	N/A
N/A	Any Obstructions?	N/A	N/A	Storm Grate/Utility Hazard?	N/A
	Obstruction Type			Storm Grate/Utility Type	
		N/A			N/A
			Yes	Surface Condition? (G/P)	Good
			No	Curb Slope (%)	6.6

**Remove & Replace Curb Ramp With Two New Directional Ramps or Equivalent.**
