Access Compliance Report

Public Rights-of-Way

(Curb Ramps)

Intersection ID: 15175	Main Street: SOUTH_BV	Cross Street: POINDEXTER_DR	Location: SE
ADA ID: 637A5B442C11	Ramp Type: PerpDiag	Initial Pass/Fail: Fail	Overall Compliance: No
Codes/Mitigation Info/Possible Solution		Field Measurements/Component Compliance

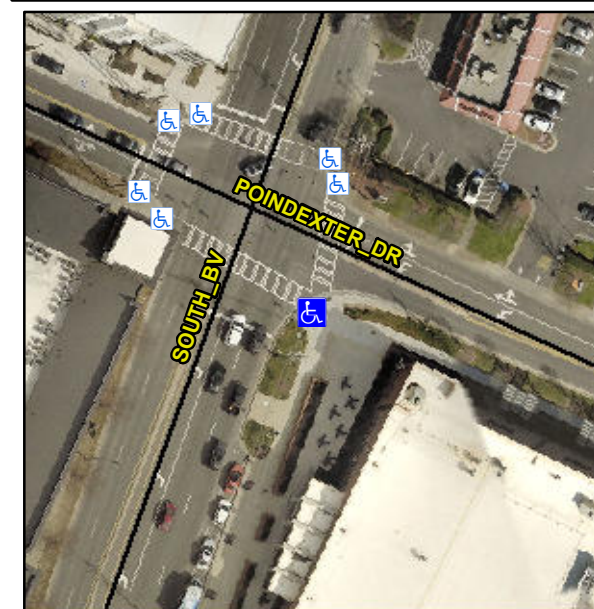
R304.2.2, R304.5.3

Compliance	Description	Data	Compliance	Description	Data
N/A	Ramp Length (in)	144.0	No	Ramp Slope (%)	8.4
Yes	Ramp Width (in)	137.0	No	Ramp XSlope (%)	4.2
N/A	Flare Type LT	N/A	N/A	Flare Type RT	N/A
N/A	Flare Slope LT (%)	N/A	N/A	Flare Slope RT (%)	N/A
N/A	Flare Traversable LT?	N/A	N/A	Flare Traversable RT?	N/A
N/A	Landing Length (in)	N/A	N/A	DWS Provided?	N/A
N/A	Landing Width (in)	N/A	N/A	DWS Contrast?	N/A
N/A	Landing Slope (%)	N/A	N/A	DWS Length (in)	N/A
N/A	Landing X Slope (%)	N/A	N/A	DWS Full Width?	N/A
N/A	Landing Curb? (Y/N)	N/A	N/A	DWS Offset (in)	N/A
N/A	Shared Landing?	N/A			
N/A	Gutter Ponding?	N/A	N/A	Gutter Slope (%)	N/A
N/A	Gutter Lip Ht (in)	N/A	N/A	Gutter X Slope (%)	N/A
N/A	Painted X Walk1?	Yes	N/A	Painted X Walk2?	Yes
	X Walk 1 Direction	To NE		X Walk 2 Direction	To NW
N/A	X Walk 1 Width (in)	114.0	N/A	X Walk 2 Width (in)	114.0
	X Walk 1 Slope (%)	4.0		X Walk 2 Slope (%)	5.0
	X Walk 1 X Slope (%)	5.0		X Walk 2 X Slope (%)	1.0

N/A	Ramp inside XWalk1?	Yes	N/A	Ramp inside XWalk2?	Yes
	Road Slope (%)	4.0	N/A	Clear Space?	N/A
	Road X Slope (%)	3.9	N/A	Clear Space to XWalk (in)	N/A
N/A	Any Obstructions?	N/A	N/A	Storm Grate/Utility Hazard?	N/A
	Obstruction Type			Storm Grate/Utility Type	
		N/A			N/A
		Yes		Surface Condition? (G/P)	Good

Remove & Replace Curb Ramp With Two New Directional Ramps or Equivalent.
