# Access Compliance Report

## Public Rights-of-Way

### (Curb Ramps)

Intersection ID: 4475	Main Street: PANTHER_PL	Cross Street: COUGAR_LN	Location: NW
ADA ID: 639DECF63BE1	Ramp Type: Perp	Initial Pass/Fail: Fail	Overall Compliance: No
Severity Score: 21.25			
Codes/Mitigation Info/Possible Solution		Field Measurements/Component Compliance

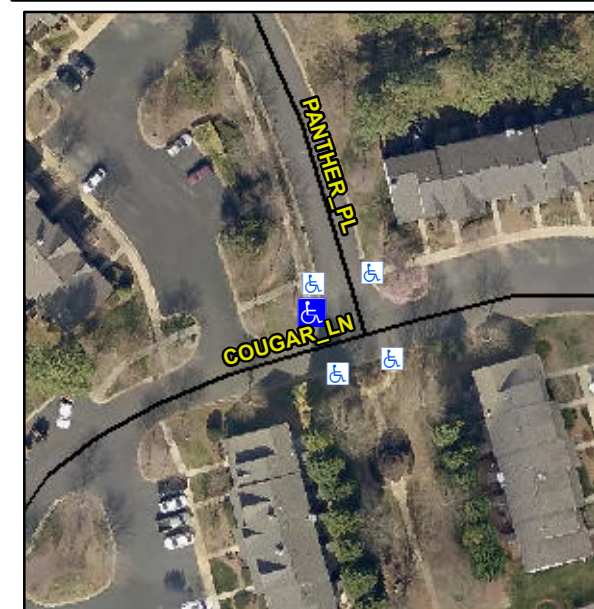
**Not Found, R304.5.1, R304.2.2**

Compliance	Description	Data	Compliance	Description	Data
N/A	Ramp Length (in)	54.0	No	Ramp Slope (%)	10.1
No	Ramp Width (in)	44.0	Yes	Ramp XSlope (%)	0.7
N/A	Flare Type LT	N/A	N/A	Flare Type RT	N/A
N/A	Flare Slope LT (%)	N/A	N/A	Flare Slope RT (%)	N/A
N/A	Flare Traversable LT?	N/A	N/A	Flare Traversable RT?	N/A
N/A	Landing Length (in)	N/A	N/A	DWS Provided?	N/A
N/A	Landing Width (in)	N/A	N/A	DWS Contrast?	N/A
N/A	Landing Slope (%)	N/A	N/A	DWS Length (in)	N/A
N/A	Landing X Slope (%)	N/A	N/A	DWS Full Width?	N/A
N/A	Landing Curb? (Y/N)	N/A	N/A	DWS Offset (in)	N/A
N/A	Shared Landing?	N/A			
N/A	Gutter Ponding?	N/A	N/A	Gutter Slope (%)	N/A
N/A	Gutter Lip Ht (in)	N/A	N/A	Gutter X Slope (%)	N/A
N/A	Painted X Walk1?	No	N/A	Painted X Walk2?	N/A
	X Walk 1 Direction	To SW		X Walk 2 Direction	N/A
N/A	X Walk 1 Width (in)	N/A	N/A	X Walk 2 Width (in)	N/A
	X Walk 1 Slope (%)	0.8		X Walk 2 Slope (%)	N/A
	X Walk 1 X Slope (%)	2.2		X Walk 2 X Slope (%)	N/A

N/A	Ramp inside XWalk1?	N/A	N/A	Ramp inside XWalk2?	N/A
	Road Slope (%)	N/A	N/A	Clear Space?	N/A
	Road X Slope (%)	N/A	N/A	Clear Space to XWalk (in)	N/A
N/A	Any Obstructions?	N/A	N/A	Storm Grate/Utility Hazard?	N/A
	Obstruction Type			Storm Grate/Utility Type	
		N/A			N/A
			Yes	Surface Condition? (G/P)	Good

Possible Solutions:

**Remove & Replace Entire Ramp.**

Total Cost: \$ 1850.00
