Access Compliance Report Public Rights-of-Way (Curb Ramps)

| Intersection ID: 21206 | Main Street: NORTHAMPTON_DR | | | Street: | PARK_RD | Location: | NW | | |
| ADA ID: 63A1CA4AB18D | Ramp Type: PerpDiag | | | nitial Pass/Fail: Fail Overall Compliance: No | | | | o Severity Score: | 37.5 |

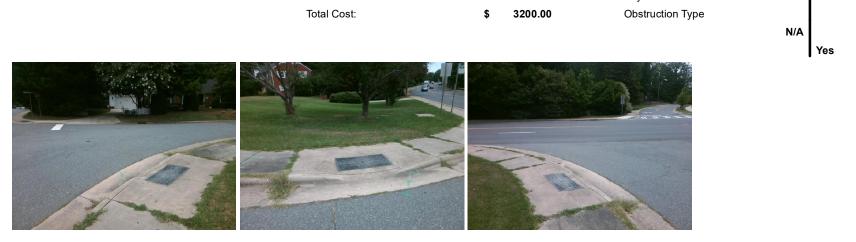
| | | Remove & Replace Curb Ramp V | Nith | N/A | Ramp Length (in) | 60.0 | No | Ramp Slope (%) | 8.5 |
| | | Two New Directional Ramps or | V ICII | Yes | Ramp Width (in) | 48.0 | No | Ramp XSlope (%) | 7.8 |
| | Not Found, R304.2.2, R304.5.3 | | N/A | Gutter Lip Ht (in) | N/A | N/A | Gutter X Slope (%) | N/A | |

| | Possible Solutions: | | | | | | | | |
| | | Equivalent. | | N/A | Flare Type LT | N/A | N/A | Flare Type RT | N/A |
| | | Total Cost: \$ 3 | 200.00 | | Obstruction Type | | | Storm Grate/Utility Type | |
