Intersection ID: 20188	Main Street: ASSEMBLY_ST	Cross Street: FAIRVIEW RD	Location:	NW
ADA ID: 63C1275D64EC	Ramp Type: Perp	Initial Pass/Fail: Fail	Overall Compliance: No	Severity Score: 8.75

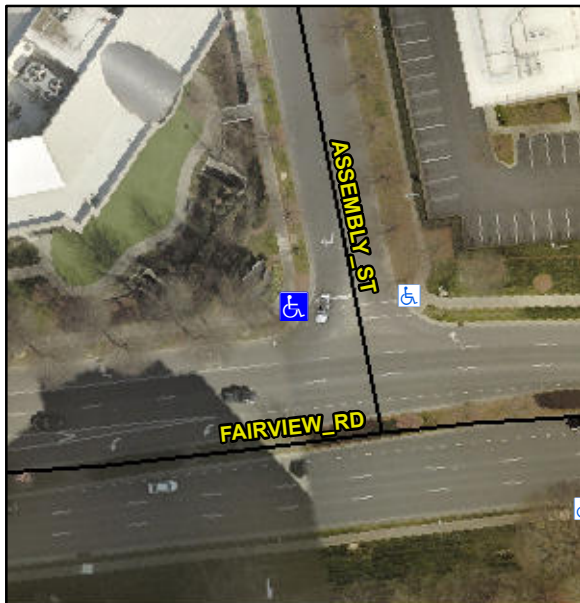
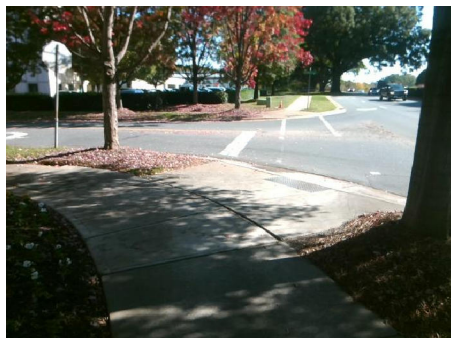
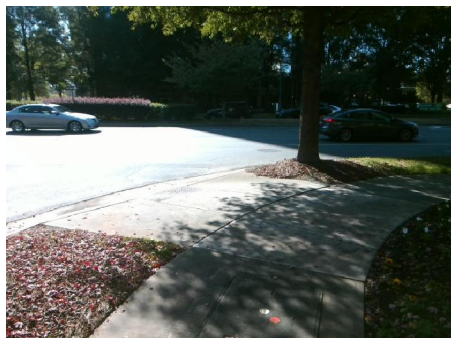
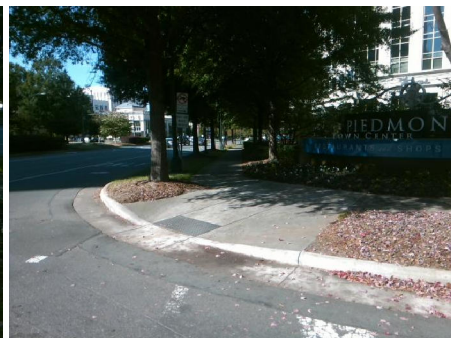
Possible Solutions:		Compliance	Description	Data	Compliance	Description	Data
	Remove & Replace Entire Ramp.		N/A	Ramp Length (in)	97.5	Yes	Ramp Slope (%)	6.9
			No	Ramp Width (in)	47.0	Yes	Ramp XSlope (%)	0.7
			N/A	Flare Type LT	N/A	N/A	Flare Type RT	N/A
			N/A	Flare Slope LT (%)	N/A	N/A	Flare Slope RT (%)	N/A
			N/A	Flare Traversable LT?	N/A	N/A	Flare Traversable RT?	N/A
			N/A	Landing Length (in)	N/A	N/A	DWS Provided?	N/A
			N/A	Landing Width (in)	N/A	N/A	DWS Contrast?	N/A
			N/A	Landing Slope (%)	N/A	N/A	DWS Length (in)	N/A
			N/A	Landing X Slope (%)	N/A	N/A	DWS Full Width?	N/A
Street 1 Name Stop Condition-Street 2 Street 2 Name Stop Condition-Street 1	Surveyor Notes:		N/A	Landing Curb? (Y/N)	N/A	N/A	DWS Offset (in)	N/A
	N/A		N/A	Shared Landing?	N/A			
	PROW/ADA:		N/A	Gutter Ponding?	N/A	N/A	Gutter Slope (%)	N/A

Not Found, R304.5.1		N/A	Gutter Lip Ht (in)	N/A	N/A	Gutter X Slope (%)	N/A
			N/A	Painted X Walk1?	Yes	N/A	Painted X Walk2?	N/A
				X Walk 1 Direction	To E		X Walk 2 Direction	N/A
			N/A	X Walk 1 Width (in)	87.0	N/A	X Walk 2 Width (in)	N/A
				X Walk 1 Slope (%)	0.3		X Walk 2 Slope (%)	N/A
				X Walk 1 X Slope (%)	0.0		X Walk 2 X Slope (%)	N/A
			N/A	Ramp inside XWalk1?	Yes	N/A	Ramp inside XWalk2?	N/A
			Road Slope (%)	N/A	N/A	Clear Space?	N/A	
			Road X Slope (%)	N/A	N/A	Clear Space to XWalk (in)	N/A	
		N/A	Any Obstructions?	N/A	N/A	Storm Grate/Utility Hazard?	N/A	
			Obstruction Type			Storm Grate/Utility Type		
					N/A			N/A
						Yes	Surface Condition? (G/P)	Good
Total Cost:		\$ 1850.00
