Access Compliance Report Public Rights-of-Way (Curb Ramps)

_	_						
Intersection ID: 9004	Main Street: BOYD_ST			Cı	Cross Street: MARIETTA_ST				Location:	N
ADA ID: 63D09ED20485	Ramp Ty	Ramp Type: Perp			Initial Pass/Fail: Fail Overall Compliance: No				o Severity Score:	33.75
Codes/Mitigation Info/Possible Solution					Field Measurements/Component Compliance					
A A A A A A A A A A A A A A A A A A A	States and	Possible Solution	S:		Com	liance Description	Data	Comp	liance Description	Data
		Remove & R	eplace Entire Ra	mp.	N/A	Ramp Length (in)	45.0	No	Ramp Slope (%)	9.5

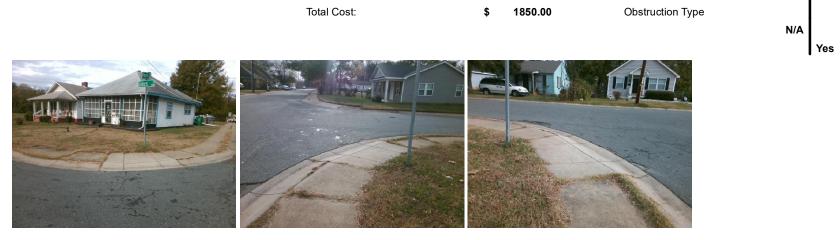
- 1 - 3		-	-	No	Ramp Width (in)	39.0	No	Ramp XSlope (%)	6.1
	the the				N/A	Flare Type LT	N/A	N/A	Flare Type RT	N/A
	1 1 1 1 1				N/A	Flare Slope LT (%)	N/A	N/A	Flare Slope RT (%)	N/A
	10 12 1				N/A	Flare Traversable LT?	N/A	N/A	Flare Traversable RT?	N/A
	1 11	1			N/A	Landing Length (in)	N/A	N/A	DWS Provided?	N/A
	and the	Surveyor Notes:			N/A	Landing Width (in)	N/A	N/A	DWS Contrast?	N/A
Le la	C. R. C.	N/A			N/A	Landing Slope (%)	N/A	N/A	DWS Length (in)	N/A
6	- (C.) >				N/A	Landing X Slope (%)	N/A	N/A	DWS Full Width?	N/A
					N/A	Landing Curb? (Y/N)	N/A	N/A	DWS Offset (in)	N/A
					N/A	Shared Landing?	N/A			
	8 Ann	PROW/ADA:			N/A	Gutter Ponding?	N/A	N/A	Gutter Slope (%)	N/A
and a set of the set o	Constant of	Not Found.	R304.5.1, R304.2	.2.	N/A	Gutter Lip Ht (in)	N/A	N/A	Gutter X Slope (%)	N/A
	A States	R304.5.3	,	,	N/A	Painted X Walk1?	No	N/A	Painted X Walk2?	N/A
	4 and					X Walk 1 Direction	To SE		X Walk 2 Direction	N/A
