Access Compliance Report Public Rights-of-Way (Curb Ramps)

Intersection ID: 52716 Main Street: AGAVA LN **Cross Street: MAIDENHAIR CT** Location: ADA ID: 63DB6C48D349 Ramp Type: Perp Initial Pass/Fail: Fail **Overall Compliance: No** Severity Score: 13.75

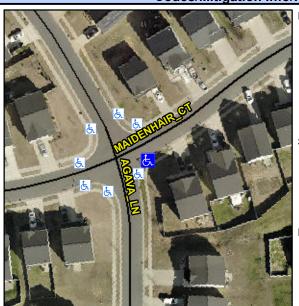
Compliance Description		Data	Compliance		Description
N/A	Ramp Length (in)	47.0	No	Ram	Slope (%)
Yes	Ramp Width (in)	48.0	No	Ramp	XSlope (%)
N/A	Flare Type LT	N/A	N/A	Flare	Type RT
N/A	Flare Slope LT (%)	N/A	N/A	Flare	Slope RT (%)
N/A	Flare Traversable LT?	N/A	N/A	Flare	Traversable RT?
N/A	Landing Length (in)	N/A	N/A	DWS	Provided?
N/A	Landing Width (in)	N/A	N/A	DWS	Contrast?
N/A	Landing Slope (%)	N/A	N/A	DWS	Length (in)
N/A	Landing X Slope (%)	N/A	N/A	DWS	Full Width?
N/A	Landing Curb? (Y/N)	N/A	N/A	DWS	Offset (in)
N/A	Shared Landing?	N/A			
N/A	Gutter Ponding?	N/A	N/A	Gutte	er Slope (%)
N/A	Gutter Lip Ht (in)	N/A	N/A	Gutte	er X Slope (%)
N/A	Painted X Walk1?	No	N/A	Paint	ed X Walk2?
	X Walk 1 Direction	To N		X Wa	lk 2 Direction
N/A	X Walk 1 Width (in)	N/A	N/A	X Wa	lk 2 Width (in)
	X Walk 1 Slope (%)	3.5		X Wa	lk 2 Slope (%)
	X Walk 1 X Slope (%)	2.5		X Wa	lk 2 X Slope (%)
N/A	Ramp inside XWalk1?	N/A	N/A	Ram	o inside XWalk2?

MAIDENHAIR CT Street 1 Name Stop Condition-Street 2 StopSign N/A Street 2 Name Stop Condition-Street 1 N/A Possible Solutions: Remove & Replace Entire Ramp. Surveyor Notes: N/A PROW/ADA: Not Found, R304.2.2, R304.5.3
