# Access Compliance Report

## Public Rights-of-Way

### (Curb Ramps)

Intersection ID: 15974	Main Street: STEGALL_ST	Cross Street: W_CAMA_ST	Location: SW
ADA ID: 63E6C1F3F992	Ramp Type: PerpDiag	Initial Pass/Fail: Fail	Overall Compliance: No
		Severity Score: 22.5

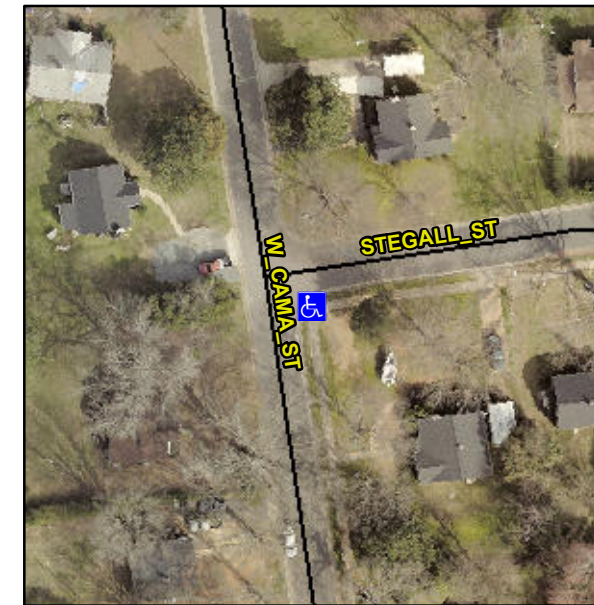
**Not Found, R304.5.1, R304.2.2, R304.5.3**

Compliance	Description	Data	Compliance	Description	Data
N/A	Ramp Length (in)	107.0	No	Ramp Slope (%)	8.7
No	Ramp Width (in)	47.0	No	Ramp XSlope (%)	2.8
N/A	Flare Type LT	N/A	N/A	Flare Type RT	N/A
N/A	Flare Slope LT (%)	N/A	N/A	Flare Slope RT (%)	N/A
N/A	Flare Traversable LT?	N/A	N/A	Flare Traversable RT?	N/A
N/A	Landing Length (in)	N/A	N/A	DWS Provided?	N/A
N/A	Landing Width (in)	N/A	N/A	DWS Contrast?	N/A
N/A	Landing Slope (%)	N/A	N/A	DWS Length (in)	N/A
N/A	Landing X Slope (%)	N/A	N/A	DWS Full Width?	N/A
N/A	Landing Curb? (Y/N)	N/A	N/A	DWS Offset (in)	N/A
N/A	Shared Landing?	N/A			
N/A	Gutter Ponding?	N/A	N/A	Gutter Slope (%)	N/A
N/A	Gutter Lip Ht (in)	N/A	N/A	Gutter X Slope (%)	N/A
N/A	Painted X Walk1?	No	N/A	Painted X Walk2?	No
	X Walk 1 Direction	To N		X Walk 2 Direction	To W
N/A	X Walk 1 Width (in)	N/A	N/A	X Walk 2 Width (in)	N/A
	X Walk 1 Slope (%)	2.0		X Walk 2 Slope (%)	1.9
	X Walk 1 X Slope (%)	1.8		X Walk 2 X Slope (%)	0.8

N/A	Ramp inside XWalk1?	N/A	N/A	Ramp inside XWalk2?	N/A
	Road Slope (%)	2.4	N/A	Clear Space?	N/A
	Road X Slope (%)	0.3	N/A	Clear Space to XWalk (in)	N/A
N/A	Any Obstructions?	N/A	N/A	Storm Grate/Utility Hazard?	N/A
	Obstruction Type			Storm Grate/Utility Type	
		N/A			N/A
			Yes	Surface Condition? (G/P)	Good

**Remove & Replace Curb Ramp With Two New Directional Ramps or Equivalent.**

Total Cost: \$ 3200.00
