Access Compliance Report Public Rights-of-Way (Curb Ramps)

Intersection ID: 28373 Main Street: ASTOR HALL DR **Cross Street: SOUTHAMPTON COMMONS DR** Location: NW ADA ID: 63F2C2125D4A Ramp Type: PerpDiag Initial Pass/Fail: Fail **Overall Compliance: No Severity Score:** 12.5

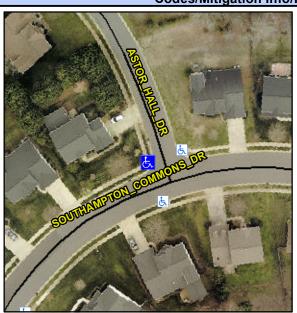
N/A	Ramp Length (in)
Yes	Ramp Width (in)
N/A	Flare Type LT
N/A	Flare Slope LT (%
N/A	Flare Traversable
N/A	Landing Length (in
N/A	Landing Width (in)
N/A	Landing Slope (%
N/A	Landing X Slope (
N/A	Landing Curb? (Y
N/A	Shared Landing?
N/A	Gutter Ponding?
N/A	Gutter Lip Ht (in)
N/A	Painted X Walk1?
	X Walk 1 Direction
N/A	X Walk 1 Width (ir
	X Walk 1 Slope (%
	X Walk 1 X Slope
N/A	Ramp inside XWa
	Road Slope (%)
	Road X Slope (%)
N/A	Any Obstructions?

. tab . to.obo (/o)	
/ A	Flare Type LT	N/A	N/A	Flare Type RT	
/ A	Flare Slope LT (%)	N/A	N/A	Flare Slope RT (%)	
/ A	Flare Traversable LT?	N/A	N/A	Flare Traversable RT?	
/ A	Landing Length (in)	N/A	N/A	DWS Provided?	
/ A	Landing Width (in)	N/A	N/A	DWS Contrast?	
/ A	Landing Slope (%)	N/A	N/A	DWS Length (in)	
/ A	Landing X Slope (%)	N/A	N/A	DWS Full Width?	
/ A	Landing Curb? (Y/N)	N/A	N/A	DWS Offset (in)	
/ A	Shared Landing?	N/A			
/ A	Gutter Ponding?	N/A	N/A	Gutter Slope (%)	
/ A	Gutter Lip Ht (in)	N/A	N/A	Gutter X Slope (%)	
/ A	Painted X Walk1?	No	N/A	Painted X Walk2?	
	X Walk 1 Direction	To S		X Walk 2 Direction	
/ A	X Walk 1 Width (in)	N/A	N/A	X Walk 2 Width (in)	
	X Walk 1 Slope (%)	3.6		X Walk 2 Slope (%)	
	X Walk 1 X Slope (%)	4.4		X Walk 2 X Slope (%)	
/ A	Ramp inside XWalk1?	N/A	N/A	Ramp inside XWalk2?	
	Road Slope (%)	4.2	N/A	Clear Space?	
	Road X Slope (%)	2.7	N/A	Clear Space to XWalk (in)	
/ A	Any Obstructions?	N/A	N/A	Storm Grate/Utility Hazard?

055ible 30iulion
Possible Solutions:
Remove & Replace Curb Ramp With Two New Directional Ramps or Equivalent.
Surveyor Notes:
N/A
PROW/ADA:
Not Found, R304.2.2
