# Access Compliance Report

## Public Rights-of-Way

| Intersection ID: N/A | Main Street: UNION_PACIFIC_AV | Cross Street: BELLE_VERNON_AV | Location: E |
| ADA ID: 63FF36F395F5 | Ramp Type: PerpDiag | Initial Pass/Fail: Fail | Overall Compliance: No |

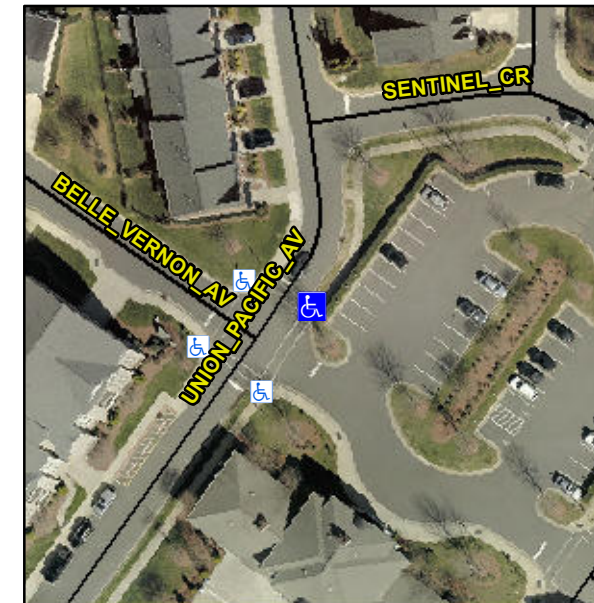
**Not Found, R304.5.1, R304.2.2, R304.5.3**

| Compliance | Description | Data | Compliance | Description | Data |
|---|---|---|---|---|---|
| N/A | Ramp Length (in) | 43.0 | No | Ramp Slope (%) | 9.0 |
| No | Ramp Width (in) | 46.0 | No | Ramp XSlope (%) | 6.7 |

**Remove & Replace Curb Ramp With Two New Directional Ramps or Equivalent.**

Total Cost: \$ 3200.00
