Access Compliance Report

Public Rights-of-Way

(Curb Ramps)

Intersection ID: 14273	Main Street: BAXTER_ST	Cross Street: CHERRY_ST	Location: SW
ADA ID: 640349AFC06C	Ramp Type: Directional1	Initial Pass/Fail: Fail	Overall Compliance: No
		Severity Score: 12.5

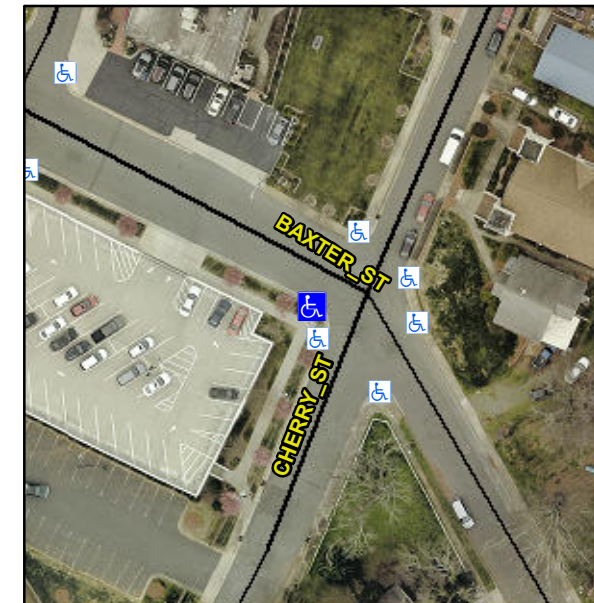
R304.5.3

Compliance	Description	Data	Compliance	Description	Data
N/A	Ramp Length (in)	82.0	N/A	Grade Break?	N/A
Yes	Ramp Width (in)	64.0	N/A	Grade Break Slope (%)	0.0
Yes	Ramp Slope (%)	2.5	N/A	Grade Break XSlope (%)	0.0
No	Ramp XSlope (%)	5.2			
N/A	Flare Type LT	N/A	N/A	Flare Type RT	N/A
N/A	Flare Slope LT (%)	N/A	N/A	Flare Slope RT (%)	0.0
N/A	Flare Traversable LT?	N/A	N/A	Flare Traversable RT?	N/A
N/A	Landing Length (in)	0.0	N/A	DWS Provided?	N/A
N/A	Landing Width (in)	0.0	N/A	DWS Contrast?	N/A
N/A	Landing Slope (%)	0.0	N/A	DWS Length (in)	N/A
N/A	Landing X Slope (%)	0.0	N/A	DWS Full Width?	N/A
N/A	Landing Curb? (Y/N)	N/A	N/A	DWS Offset LT (in)	N/A
N/A	Shared Landing?	N/A	N/A	DWS Offset RT (in)	N/A
N/A	Gutter Ponding?	0.0	N/A	Gutter Slope (%)	N/A
N/A	Gutter Lip Ht (in)	0.0	N/A	Gutter X Slope (%)	N/A
N/A	Painted X Walk1?	No		Road Slope (%)	6.1
	X Walk 1 Direction	To NE		Road X Slope (%)	4.8
	X Walk 1 Width (in)	N/A		Clear Space?	N/A

X Walk 1 Slope (%)	6.1	N/A	Clear Space to XWalk (in)	N/A
	X Walk 1 X Slope (%)	4.8	N/A	Storm Grate/Utility Hazard?	N/A
N/A	Ramp inside XWalk1?	N/A		Storm Grate/Utility Type	
N/A	Any Obstructions?	N/A			N/A
	Obstruction Type		Yes	Surface Condition? (G/P)	Good
			N/A	Curb Slope (%)	4.9

Remove & Replace Entire Ramp.
