# Access Compliance Report

## Public Rights-of-Way

### (Curb Ramps)

| Intersection ID: 3448 | Main Street: W W T HARRIS BV TO I-77 RA SB | Access Street: I-77 TO W W T HARRIS BV RA SB | Location: NW |

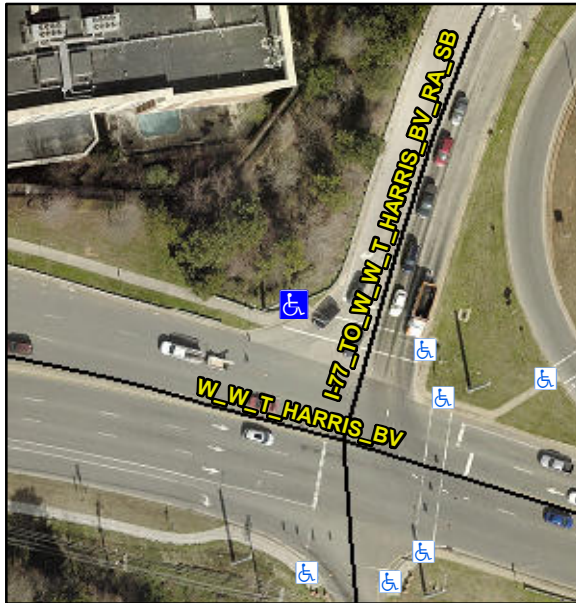
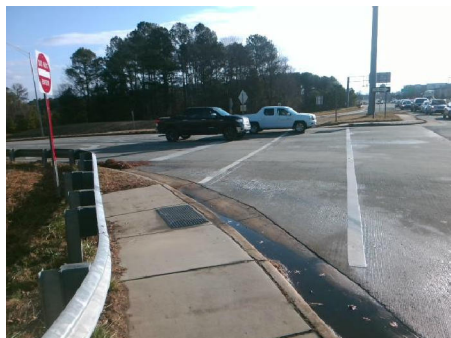
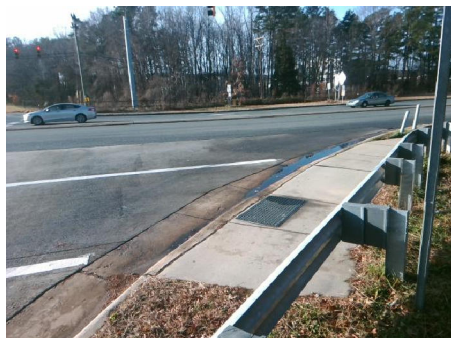
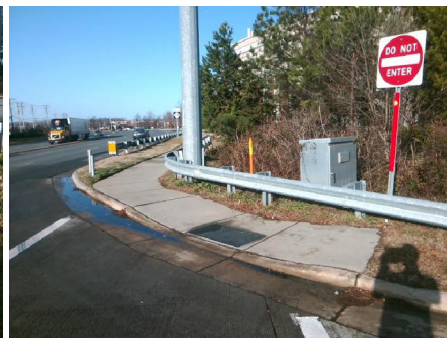
| ADA ID: 6403FA12CB2B | Ramp Type: Para | Initial Pass/Fail: Pass | Overall Compliance: No |
| Severity Score: 5.25 | | | |

**R304.5.3, R304.2.1, R302.7, R304.5.4**

| Compliance | Description | Data | Compliance | Description | Data |
|---|---|---|---|---|---|
| No | Ramp XSlope LT (%) | 2.5 | No | Ramp XSlope RT (%) | 3.1 |
| No | Landing Width (in) | 47.0 | Yes | DWS Contrast? | Yes |
| No | Gutter Ponding? | Yes | No | Gutter Slope (%) | 5.1 |

**Remove & Replace Entire Ramp.  
Remove & Replace Gutter.**
