Access Compliance Report Public Rights-of-Way (Curb Ramps)

Intersection ID: 7438 Main Street: ROCKY_RIVER_RD Cross Street: E_W_T_HARRIS_BV Location: NW **Severity Score: ADA ID: 640D77E2B8FD** Ramp Type: Perp Initial Pass/Fail: Fail **Overall Compliance: No** 37.5

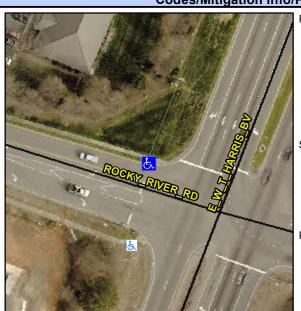
Field Measurements/Component Compliance								
Comp	liance Description	Data	Compl	iance	Description	Data		
N/A	Ramp Length (in)	36.0	No	Ramp	Slope (%)	8.6		
Yes	Ramp Width (in)	48.0	No	Ramp	XSlope (%)	10.8		
N/A	Flare Type LT	N/A	N/A	Flare	Type RT	N/A		
N/A	Flare Slope LT (%)	N/A	N/A	Flare	Slope RT (%)	N/A		
N/A	Flare Traversable LT?	N/A	N/A	Flare	Traversable RT?	N/A		
N/A	Landing Length (in)	N/A	N/A	DWS	Provided?	N/A		
N/A	Landing Width (in)	N/A	N/A	DWS	Contrast?	N/A		
N/A	Landing Slope (%)	N/A	N/A	DWS	Length (in)	N/A		
N/A	Landing X Slope (%)	N/A	N/A	DWS	Full Width?	N/A		
N/A	Landing Curb? (Y/N)	N/A	N/A	DWS	Offset (in)	N/A		
N/A	Shared Landing?	N/A						
N/A	Gutter Ponding?	N/A	N/A	Gutte	r Slope (%)	N/A		
N/A	Gutter Lip Ht (in)	0.5	N/A	Gutte	r X Slope (%)	N/A		
N/A	Painted X Walk1?	No	N/A	Paint	ed X Walk2?	N/A		
	X Walk 1 Direction	To S		X Wa	lk 2 Direction	N/A		
N/A	X Walk 1 Width (in)	N/A	N/A	X Wa	lk 2 Width (in)	N/A

X Walk 1 Slope (%)	3.0		X Wa	lk 2 Slope (%)	N/A		
	X Walk 1 X Slope (%)	8.2		X Wa	lk 2 X Slope (%)	N/A		
N/A	Ramp inside XWalk1?	N/A	N/A	Ramp	inside XWalk2?	N/A		
	Road Slope (%)	N/A	N/A	Clear	Space?	N/A		
	Road X Slope (%)	N/A	N/A	Clear	Space to XWalk (in)	N/A		
N/A	Any Obstructions?	N/A	N/A	Storm	n Grate/Utility Hazard?	N/A		
	Obstruction Type			Storm	Grate/Utility Type			
		N/A				N/A		
			Yes	Surfa	ce Condition? (G/P)	Good		
A 100 M 100 M

Remove & Replace Entire Ramp.	1 1 1 1 1 1 1 1 1 1 1 1 1 1 1 1 1 1 1 1
	1
	1
	ı
	ı
Surveyor Notes:	ı
N/A	•
DDOM/ADA.	
PROW/ADA:	
Not Found, R304.2.2, R304.5.3	1
	ı
	•
	•
