# Access Compliance Report

## Public Rights-of-Way

### (Curb Ramps)

Intersection ID: 28847	Main Street: BERWICK_RD	Cross Street: FAIRCHASE_AV	Location:	N
ADA ID: 6412FBE93018	Ramp Type: Perp	Initial Pass/Fail: Fail	Overall Compliance: No	Severity Score: 10

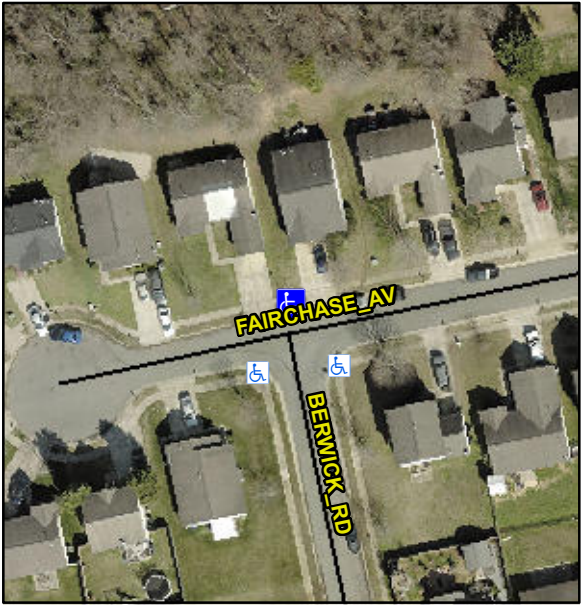
Possible Solutions:	<b>Remove &amp; Replace Entire Ramp.</b>					
	Surveyor Notes:	N/A					
	PROW/ADA:	Not Found, R304.5.1					
	Street 1 Name	FAIRCHASE AV					
	Stop Condition-Street 2	None					
	Street 2 Name	N/A					
	Stop Condition-Street 1	N/A					
	Total Cost:	\$ 1850.00					
		Compliance	Description	Data	Compliance	Description	Data
		N/A	Ramp Length (in)	49.0	Yes	Ramp Slope (%)	5.2
		No	Ramp Width (in)	45.0	Yes	Ramp XSlope (%)	2.1
		N/A	Flare Type LT	N/A	N/A	Flare Type RT	N/A
		N/A	Flare Slope LT (%)	N/A	N/A	Flare Slope RT (%)	N/A
		N/A	Flare Traversable LT?	N/A	N/A	Flare Traversable RT?	N/A
		N/A	Landing Length (in)	N/A	N/A	DWS Provided?	N/A
		N/A	Landing Width (in)	N/A	N/A	DWS Contrast?	N/A
		N/A	Landing Slope (%)	N/A	N/A	DWS Length (in)	N/A
		N/A	Landing X Slope (%)	N/A	N/A	DWS Full Width?	N/A
		N/A	Landing Curb? (Y/N)	N/A	N/A	DWS Offset (in)	N/A

N/A	Shared Landing?	N/A			
		N/A	Gutter Ponding?	N/A	N/A	Gutter Slope (%)	N/A
		N/A	Gutter Lip Ht (in)	N/A	N/A	Gutter X Slope (%)	N/A
		N/A	Painted X Walk1?	No	N/A	Painted X Walk2?	N/A
			X Walk 1 Direction	To S		X Walk 2 Direction	N/A
		N/A	X Walk 1 Width (in)	N/A	N/A	X Walk 2 Width (in)	N/A
			X Walk 1 Slope (%)	4.6		X Walk 2 Slope (%)	N/A
			X Walk 1 X Slope (%)	2.5		X Walk 2 X Slope (%)	N/A
		N/A	Ramp inside XWalk1?	N/A	N/A	Ramp inside XWalk2?	N/A
			Road Slope (%)	N/A	N/A	Clear Space?	N/A
			Road X Slope (%)	N/A	N/A	Clear Space to XWalk (in)	N/A
		N/A	Any Obstructions?	N/A	N/A	Storm Grate/Utility Hazard?	N/A
			Obstruction Type			Storm Grate/Utility Type	
				N/A			N/A
					Yes	Surface Condition? (G/P)	Good
