Access Compliance Report

Public Rights-of-Way

(Curb Ramps)

Intersection ID: 52599	Main Street: W_TYVOLA_RD	Cross Street: POTOMAC_RIVER_PY	Location: NE
ADA ID: 642096866296	Ramp Type: PerpDiag	Initial Pass/Fail: Fail	Overall Compliance: No
Severity Score: 8.75			
Codes/Mitigation Info/Possible Solution		Field Measurements/Component Compliance

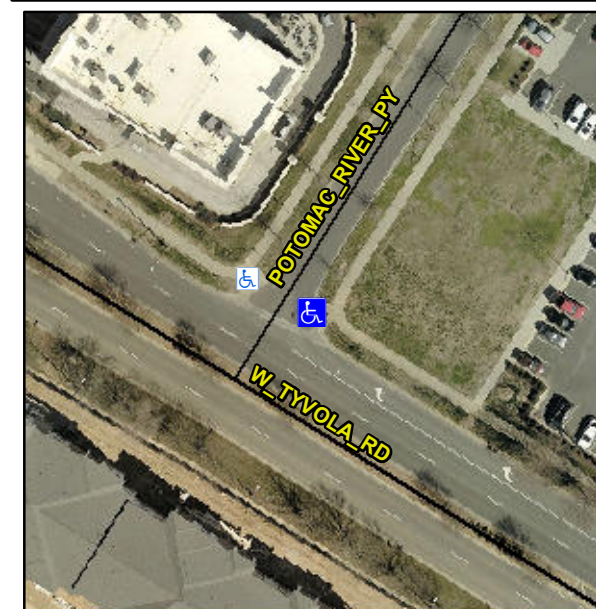
Compliance	Description	Data	Compliance	Description	Data
N/A	Ramp Length (in)	96.0	Yes	Ramp Slope (%)	6.2
No	Ramp Width (in)	43.5	Yes	Ramp XSlope (%)	1.6
N/A	Flare Type LT	N/A	N/A	Flare Type RT	N/A
N/A	Flare Slope LT (%)	N/A	N/A	Flare Slope RT (%)	N/A
N/A	Flare Traversable LT?	N/A	N/A	Flare Traversable RT?	N/A
N/A	Landing Length (in)	N/A	N/A	DWS Provided?	N/A
N/A	Landing Width (in)	N/A	N/A	DWS Contrast?	N/A
N/A	Landing Slope (%)	N/A	N/A	DWS Length (in)	N/A
N/A	Landing X Slope (%)	N/A	N/A	DWS Full Width?	N/A
N/A	Landing Curb? (Y/N)	N/A	N/A	DWS Offset (in)	N/A
N/A	Shared Landing?	N/A			
N/A	Gutter Ponding?	N/A	N/A	Gutter Slope (%)	N/A
N/A	Gutter Lip Ht (in)	N/A	N/A	Gutter X Slope (%)	N/A
N/A	Painted X Walk1?	No	N/A	Painted X Walk2?	No
	X Walk 1 Direction	To NW		X Walk 2 Direction	To SW
N/A	X Walk 1 Width (in)	N/A	N/A	X Walk 2 Width (in)	N/A
	X Walk 1 Slope (%)	0.4		X Walk 2 Slope (%)	0.4
	X Walk 1 X Slope (%)	0.1		X Walk 2 X Slope (%)	0.6

N/A	Ramp inside XWalk1?	N/A	N/A	Ramp inside XWalk2?	N/A
	Road Slope (%)	1.0	N/A	Clear Space?	N/A
	Road X Slope (%)	0.4	N/A	Clear Space to XWalk (in)	N/A
N/A	Any Obstructions?	N/A	N/A	Storm Grate/Utility Hazard?	N/A
	Obstruction Type			Storm Grate/Utility Type	
		N/A			N/A
		Yes		Surface Condition? (G/P)	Good

Possible Solutions:

Remove & Replace Curb Ramp With Two New Directional Ramps or Equivalent.

Not Found, R304.5.1
