# Access Compliance Report

## Public Rights-of-Way

### (Curb Ramps)

Intersection ID: 20946	Main Street: PARK_SOUTH_DR	Cross Street: TEVERSHAM_LN	Location: S
ADA ID: 64213E58B817	Ramp Type: PerpDiag	Initial Pass/Fail: Fail	Overall Compliance: No
Severity Score: 46.25			
Codes/Mitigation Info/Possible Solution		Field Measurements/Component Compliance

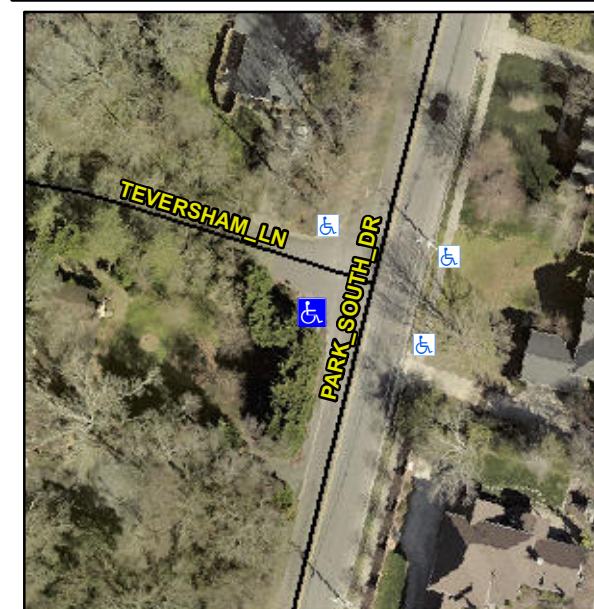
**Not Found, R304.5.1, R304.2.2, R304.5.3**

Compliance	Description	Data	Compliance	Description	Data
N/A	Ramp Length (in)	47.0	No	Ramp Slope (%)	18.0
No	Ramp Width (in)	44.0	No	Ramp XSlope (%)	5.4
N/A	Flare Type LT	N/A	N/A	Flare Type RT	N/A
N/A	Flare Slope LT (%)	N/A	N/A	Flare Slope RT (%)	N/A
N/A	Flare Traversable LT?	N/A	N/A	Flare Traversable RT?	N/A
N/A	Landing Length (in)	N/A	N/A	DWS Provided?	N/A
N/A	Landing Width (in)	N/A	N/A	DWS Contrast?	N/A
N/A	Landing Slope (%)	N/A	N/A	DWS Length (in)	N/A
N/A	Landing X Slope (%)	N/A	N/A	DWS Full Width?	N/A
N/A	Landing Curb? (Y/N)	N/A	N/A	DWS Offset (in)	N/A
N/A	Shared Landing?	N/A			
N/A	Gutter Ponding?	N/A	N/A	Gutter Slope (%)	N/A
N/A	Gutter Lip Ht (in)	N/A	N/A	Gutter X Slope (%)	N/A
N/A	Painted X Walk1?	No	N/A	Painted X Walk2?	No
	X Walk 1 Direction	To SE		X Walk 2 Direction	To NE
N/A	X Walk 1 Width (in)	N/A	N/A	X Walk 2 Width (in)	N/A
	X Walk 1 Slope (%)	3.5		X Walk 2 Slope (%)	0.9
	X Walk 1 X Slope (%)	1.1		X Walk 2 X Slope (%)	3.3

**Remove & Replace Curb Ramp With Two New Directional Ramps or Equivalent.**
