Access Compliance Report

Public Rights-of-Way

(Curb Ramps)

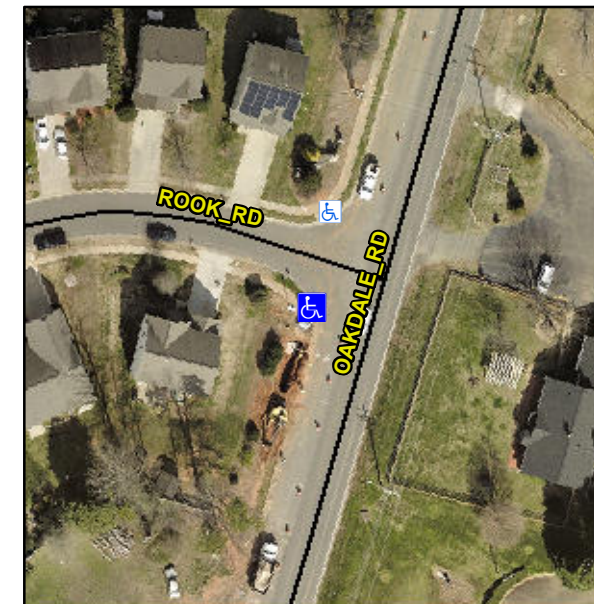
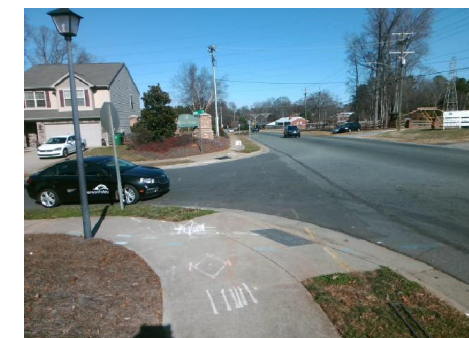
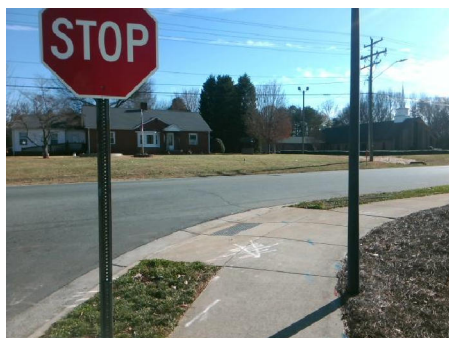
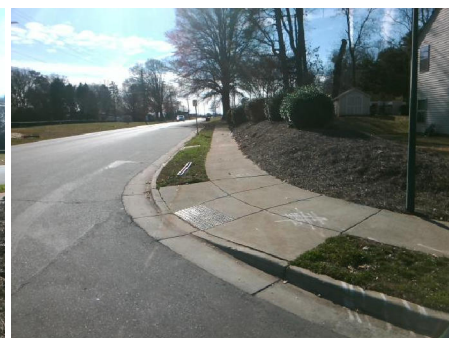
Intersection ID: 47915	Main Street: ROOK_RD	Cross Street: OAKDALE_RD	Location: SW
ADA ID: 64246088B65C	Ramp Type: Perp	Initial Pass/Fail: Fail	Overall Compliance: No
Severity Score: 13.75			
Codes/Mitigation Info/Possible Solution		Field Measurements/Component Compliance

R304.2.2, R304.5.3

Compliance	Description	Data	Compliance	Description	Data
N/A	Ramp Length (in)	49.0	No	Ramp Slope (%)	11.1
Yes	Ramp Width (in)	48.0	No	Ramp XSlope (%)	3.5
N/A	Flare Type LT	N/A	N/A	Flare Type RT	N/A
N/A	Flare Slope LT (%)	N/A	N/A	Flare Slope RT (%)	N/A
N/A	Flare Traversable LT?	N/A	N/A	Flare Traversable RT?	N/A
N/A	Landing Length (in)	N/A	N/A	DWS Provided?	N/A
N/A	Landing Width (in)	N/A	N/A	DWS Contrast?	N/A
N/A	Landing Slope (%)	N/A	N/A	DWS Length (in)	N/A
N/A	Landing X Slope (%)	N/A	N/A	DWS Full Width?	N/A
N/A	Landing Curb? (Y/N)	N/A	N/A	DWS Offset (in)	N/A
N/A	Shared Landing?	N/A			
N/A	Gutter Ponding?	N/A	N/A	Gutter Slope (%)	N/A
N/A	Gutter Lip Ht (in)	N/A	N/A	Gutter X Slope (%)	N/A
N/A	Painted X Walk1?	No	N/A	Painted X Walk2?	N/A
	X Walk 1 Direction	To NE		X Walk 2 Direction	N/A
N/A	X Walk 1 Width (in)	N/A	N/A	X Walk 2 Width (in)	N/A
	X Walk 1 Slope (%)	0.0		X Walk 2 Slope (%)	N/A
	X Walk 1 X Slope (%)	0.5		X Walk 2 X Slope (%)	N/A

N/A	Ramp inside XWalk1?	N/A	N/A	Ramp inside XWalk2?	N/A
	Road Slope (%)	N/A	N/A	Clear Space?	N/A
	Road X Slope (%)	N/A	N/A	Clear Space to XWalk (in)	N/A
N/A	Any Obstructions?	N/A	N/A	Storm Grate/Utility Hazard?	N/A
	Obstruction Type			Storm Grate/Utility Type	
		N/A			N/A
		Yes		Surface Condition? (G/P)	Good

Possible Solutions:

Remove & Replace Entire Ramp.

Total Cost: \$ 1850.00
