Access Compliance Report

Public Rights-of-Way

(Curb Ramps)

Intersection ID: 15178	Main Street: DILWORTH_RD_EAST	Cross Street: IDEAL_WY	Location: NE
ADA ID: 642A99300263	Ramp Type: Directional1	Initial Pass/Fail: Fail	Overall Compliance: No
Severity Score: 1.25			
Codes/Mitigation Info/Possible Solution		Field Measurements/Component Compliance

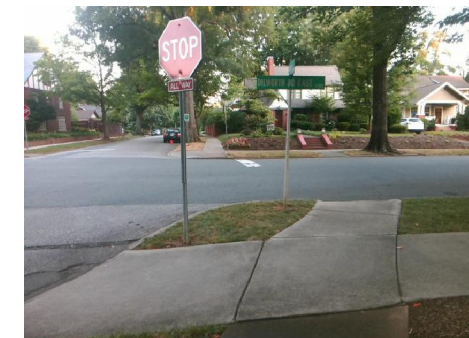
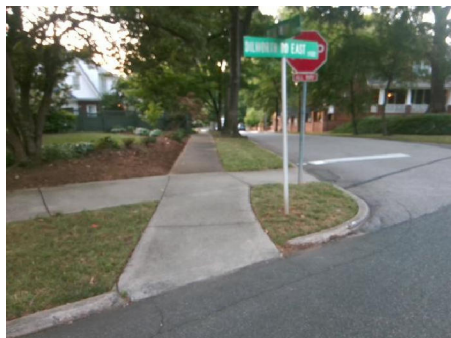
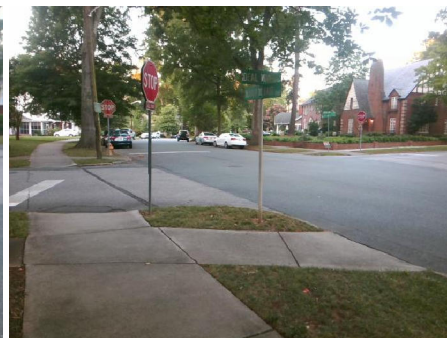
ASP LIP 1.0"

PROW/ADA:

R304.5.3

Compliance	Description	Data	Compliance	Description	Data
N/A	Ramp Length (in)	56.0	N/A	Grade Break?	N/A
Yes	Ramp Width (in)	48.0	N/A	Grade Break Slope (%)	0.0
Yes	Ramp Slope (%)	5.1	N/A	Grade Break XSlope (%)	0.0
No	Ramp XSlope (%)	2.2			
N/A	Flare Type LT	N/A	N/A	Flare Type RT	N/A
N/A	Flare Slope LT (%)	N/A	N/A	Flare Slope RT (%)	0.0
N/A	Flare Traversable LT?	N/A	N/A	Flare Traversable RT?	N/A
N/A	Landing Length (in)	0.0	N/A	DWS Provided?	N/A
N/A	Landing Width (in)	0.0	N/A	DWS Contrast?	N/A
N/A	Landing Slope (%)	0.0	N/A	DWS Length (in)	N/A
N/A	Landing X Slope (%)	0.0	N/A	DWS Full Width?	N/A
N/A	Landing Curb? (Y/N)	N/A	N/A	DWS Offset LT (in)	N/A
N/A	Shared Landing?	N/A	N/A	DWS Offset RT (in)	N/A
N/A	Gutter Ponding?	0.0	N/A	Gutter Slope (%)	N/A
N/A	Gutter Lip Ht (in)	0.0	N/A	Gutter X Slope (%)	N/A
N/A	Painted X Walk1?	No		Road Slope (%)	4.6
	X Walk 1 Direction	To W		Road X Slope (%)	1.7
	X Walk 1 Width (in)	N/A		Clear Space?	N/A

Possible Solutions:

Remove & Replace Entire Ramp.
