Access Compliance Report

Public Rights-of-Way

(Curb Ramps)

| Intersection ID: N/A | Main Street: SOUTHGROVE_ST | Cross Street: WAVERLY_WALK_AV | Location: SE |

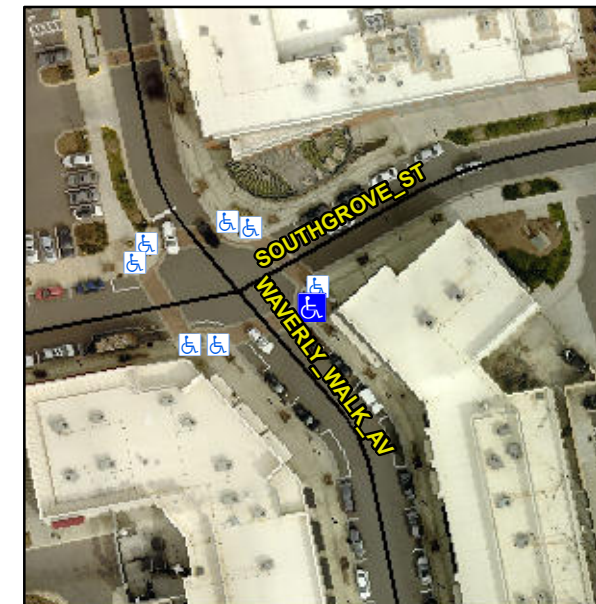
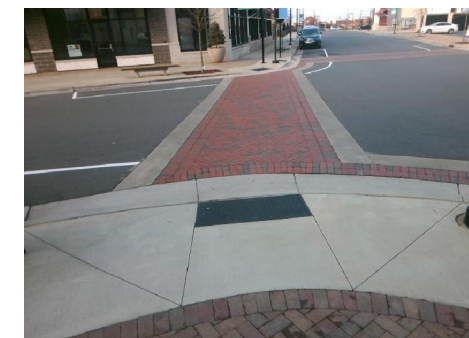
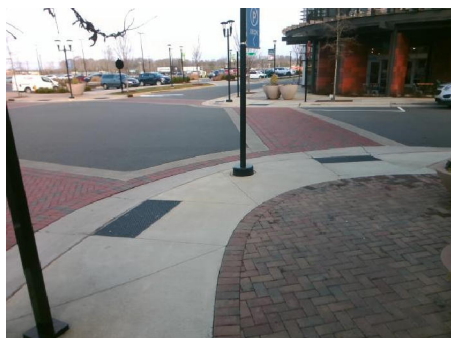
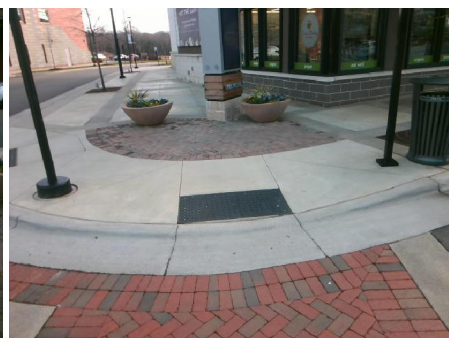
| ADA ID: 643671DC55EA | Ramp Type: Perp | Initial Pass/Fail: Fail | Overall Compliance: No |
| Severity Score: 10 | | | |

R304.5.1, R304.5.3

| Compliance | Description | Data | Compliance | Description | Data |
|---|---|---|---|---|---|
| N/A | Ramp Length (in) | 69.0 | Yes | Ramp Slope (%) | 7.5 |
| No | Ramp Width (in) | 47.0 | No | Ramp XSlope (%) | 2.3 |

Possible Solutions:

Remove & Replace Entire Ramp.

Total Cost: \$ 1850.00
