Access Compliance Report Public Rights-of-Way (Curb Ramps)

Intersection ID: 45757 Main Street: MOSS_GLEN_CT Cross Street: GRANDEUR_RD Location: NW **Overall Compliance: No** ADA ID: 6443EED309B8 Ramp Type: Perp Initial Pass/Fail: Fail **Severity Score:** 10

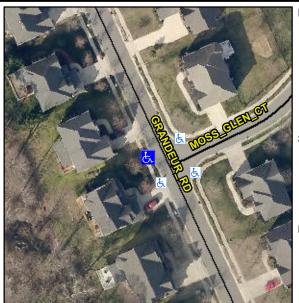
Field Measurements/Component Compliance								
Comp	liance Description	Data	Comp	liance Description	Data			
N/A	Ramp Length (in)	49.0	Yes	Ramp Slope (%)	7.3			
No	Ramp Width (in)	47.0	No	Ramp XSlope (%)	3.3			
N/A	Flare Type LT	N/A	N/A	Flare Type RT	N/A			
N/A	Flare Slope LT (%)	N/A	N/A	Flare Slope RT (%)	N/A			
N/A	Flare Traversable LT?	N/A	N/A	Flare Traversable RT?	N/A			
N/A	Landing Length (in)	N/A	N/A	DWS Provided?	N/A			
N/A	Landing Width (in)	N/A	N/A	DWS Contrast?	N/A			
N/A	Landing Slope (%)	N/A	N/A	DWS Length (in)	N/A			
N/A	Landing X Slope (%)	N/A	N/A	DWS Full Width?	N/A			
N/A	Landing Curb? (Y/N)	N/A	N/A	DWS Offset (in)	N/A			
N/A	Shared Landing?	N/A						
N/A	Gutter Ponding?	N/A	N/A	Gutter Slope (%)	N/A			
N/A	Gutter Lip Ht (in)	N/A	N/A	Gutter X Slope (%)	N/A			
N/A	Painted X Walk1?	No	N/A	Painted X Walk2?	N/A			
	X Walk 1 Direction	To E		X Walk 2 Direction	N/A			
N/A	X Walk 1 Width (in)	N/A	N/A	X Walk 2 Width (in)	N/A

X Walk 1 Slope (%)	4.9		X Walk 2 Slope (%)	N/A			
	X Walk 1 X Slope (%)	2.7		X Walk 2 X Slope (%)	N/A			
N/A	Ramp inside XWalk1?	N/A	N/A	Ramp inside XWalk2?	N/A			
	Road Slope (%)	N/A	N/A	Clear Space?	N/A			
	Road X Slope (%)	N/A	N/A	Clear Space to XWalk (in)	N/A			
N/A	Any Obstructions?	N/A	N/A	Storm Grate/Utility Hazard?	N/A			
	Obstruction Type			Storm Grate/Utility Type				
		N/A			N/A			
			Yes	Surface Condition? (G/P)	Good

Possible Solutions:	9		
Remove & Replace Entire Ramp.			
	N		
	N		
	N		
	N		
	N		
Surveyor Notes:	N		
N/A	N		
	N		
	N		
	N		
PROW/ADA:	N		
Not Found, R304.5.1, R304.5.3	N		
	N		
	N

PROW/ADA: Not Found,	R304.5.1, R304.5	5.3		N/A N/A N/A N/A
				N/A
				N/A
Total Cost:	\$		1850.00	N/A
