Access Compliance Report

Public Rights-of-Way

(Curb Ramps)

Intersection ID: 29988	Main Street: REIGATE_RD	Cross Street: BARVAS_ST	Location:	N
ADA ID: 646124201009	Ramp Type: PerpDiag	Initial Pass/Fail: Fail	Overall Compliance: No	Severity Score: 10

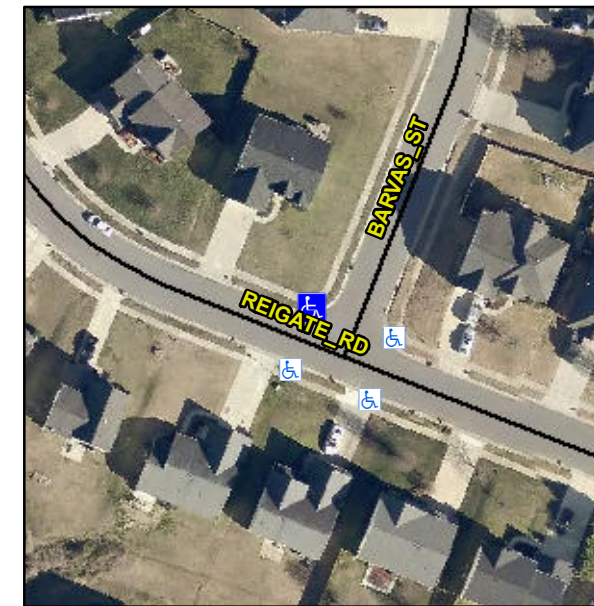
Not Found, R304.5.1, R304.5.3

Compliance	Description	Data	Compliance	Description	Data
N/A	Ramp Length (in)	48.0	Yes	Ramp Slope (%)	7.7
No	Ramp Width (in)	42.0	No	Ramp XSlope (%)	2.8
N/A	Flare Type LT	N/A	N/A	Flare Type RT	N/A
N/A	Flare Slope LT (%)	N/A	N/A	Flare Slope RT (%)	N/A
N/A	Flare Traversable LT?	N/A	N/A	Flare Traversable RT?	N/A
N/A	Landing Length (in)	N/A	N/A	DWS Provided?	N/A
N/A	Landing Width (in)	N/A	N/A	DWS Contrast?	N/A
N/A	Landing Slope (%)	N/A	N/A	DWS Length (in)	N/A
N/A	Landing X Slope (%)	N/A	N/A	DWS Full Width?	N/A
N/A	Landing Curb? (Y/N)	N/A	N/A	DWS Offset (in)	N/A
N/A	Shared Landing?	N/A			
N/A	Gutter Ponding?	N/A	N/A	Gutter Slope (%)	N/A
N/A	Gutter Lip Ht (in)	N/A	N/A	Gutter X Slope (%)	N/A
N/A	Painted X Walk1?	No	N/A	Painted X Walk2?	No
	X Walk 1 Direction	To SW		X Walk 2 Direction	To SE
N/A	X Walk 1 Width (in)	N/A	N/A	X Walk 2 Width (in)	N/A
	X Walk 1 Slope (%)	1.4		X Walk 2 Slope (%)	6.1
	X Walk 1 X Slope (%)	2.7		X Walk 2 X Slope (%)	0.1

Remove & Replace Curb Ramp With Two New Directional Ramps or Equivalent.
