Access Compliance Report

Public Rights-of-Way

(Curb Ramps)

Intersection ID: 3443	Main Street: REAMES_RD	Cross Street: PERIMETER_PY	Location: SE
ADA ID: 646AED45DE44	Ramp Type: Perp	Initial Pass/Fail: Fail	Overall Compliance: No
Codes/Mitigation Info/Possible Solution		Field Measurements/Component Compliance	
Severity Score: 33.75

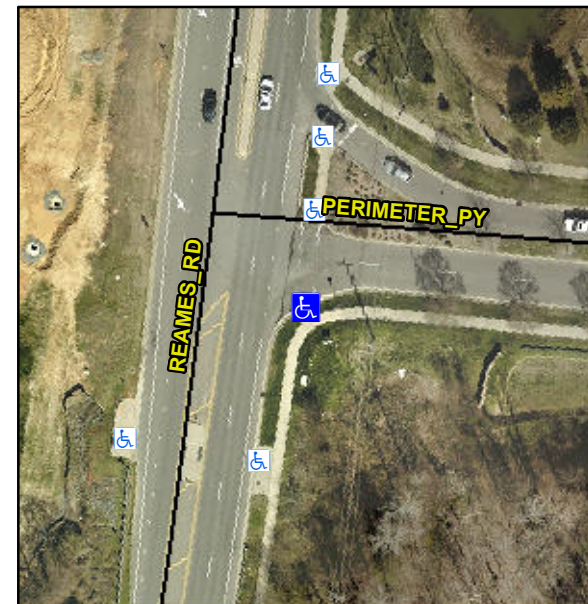
Not Found, R304.5.1, R304.5.3

Compliance	Description	Data	Compliance	Description	Data
N/A	Ramp Length (in)	59.0	Yes	Ramp Slope (%)	6.9
No	Ramp Width (in)	46.5	No	Ramp XSlope (%)	7.7
N/A	Flare Type LT	N/A	N/A	Flare Type RT	N/A
N/A	Flare Slope LT (%)	N/A	N/A	Flare Slope RT (%)	N/A
N/A	Flare Traversable LT?	N/A	N/A	Flare Traversable RT?	N/A
N/A	Landing Length (in)	N/A	N/A	DWS Provided?	N/A
N/A	Landing Width (in)	N/A	N/A	DWS Contrast?	N/A
N/A	Landing Slope (%)	N/A	N/A	DWS Length (in)	N/A
N/A	Landing X Slope (%)	N/A	N/A	DWS Full Width?	N/A
N/A	Landing Curb? (Y/N)	N/A	N/A	DWS Offset (in)	N/A
N/A	Shared Landing?	N/A			
N/A	Gutter Ponding?	N/A	N/A	Gutter Slope (%)	N/A
N/A	Gutter Lip Ht (in)	N/A	N/A	Gutter X Slope (%)	N/A
N/A	Painted X Walk1?	Yes	N/A	Painted X Walk2?	N/A
	X Walk 1 Direction	To N		X Walk 2 Direction	N/A
N/A	X Walk 1 Width (in)	100.0	N/A	X Walk 2 Width (in)	N/A
	X Walk 1 Slope (%)	0.1		X Walk 2 Slope (%)	N/A
	X Walk 1 X Slope (%)	6.0		X Walk 2 X Slope (%)	N/A

N/A	Ramp inside XWalk1?	Yes	N/A	Ramp inside XWalk2?	N/A
	Road Slope (%)	N/A	N/A	Clear Space?	N/A
	Road X Slope (%)	N/A	N/A	Clear Space to XWalk (in)	N/A
N/A	Any Obstructions?	N/A	N/A	Storm Grate/Utility Hazard?	N/A
	Obstruction Type			Storm Grate/Utility Type	
		N/A			N/A
			Yes	Surface Condition? (G/P)	Good

Possible Solutions:

Remove & Replace Entire Ramp.
