# Access Compliance Report

## Public Rights-of-Way

### (Curb Ramps)

Intersection ID: 11258	Main Street: CLOVER_HILL_LN	Cross Street: STEPPING_STONE_DR	Location: SE
ADA ID: 64711FEDAE57	Ramp Type: Directional1	Initial Pass/Fail: Fail	Overall Compliance: No
		Severity Score: 13.75

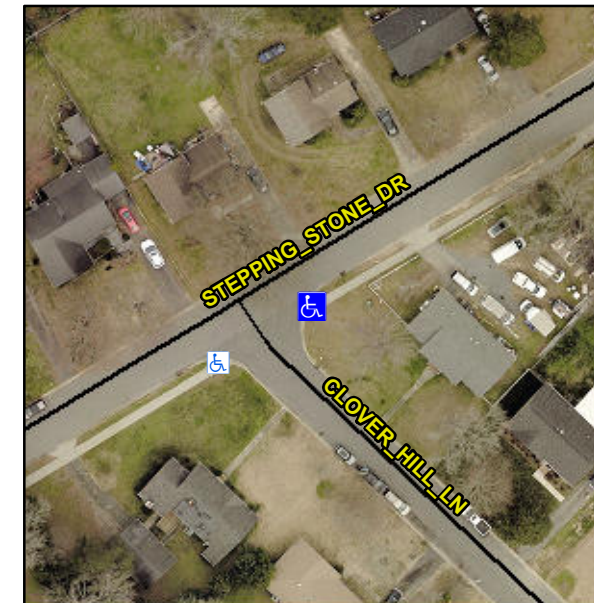
Compliance	Description	Data	Compliance	Description	Data
N/A	Ramp Length (in)	206.0	N/A	Grade Break?	N/A
Yes	Ramp Width (in)	60.0	N/A	Grade Break Slope (%)	0.0
Yes	Ramp Slope (%)	9.7	N/A	Grade Break XSlope (%)	0.0
No	Ramp XSlope (%)	2.3			
N/A	Flare Type LT	N/A	N/A	Flare Type RT	N/A
N/A	Flare Slope LT (%)	N/A	N/A	Flare Slope RT (%)	0.0
N/A	Flare Traversable LT?	N/A	N/A	Flare Traversable RT?	N/A
N/A	Landing Length (in)	0.0	N/A	DWS Provided?	N/A
N/A	Landing Width (in)	0.0	N/A	DWS Contrast?	N/A
N/A	Landing Slope (%)	0.0	N/A	DWS Length (in)	N/A
N/A	Landing X Slope (%)	0.0	N/A	DWS Full Width?	N/A
N/A	Landing Curb? (Y/N)	N/A	N/A	DWS Offset LT (in)	N/A
N/A	Shared Landing?	N/A	N/A	DWS Offset RT (in)	N/A
N/A	Gutter Ponding?	0.0	N/A	Gutter Slope (%)	N/A
N/A	Gutter Lip Ht (in)	0.0	N/A	Gutter X Slope (%)	N/A
N/A	Painted X Walk1?	No		Road Slope (%)	3.6
	X Walk 1 Direction	To SW		Road X Slope (%)	3.0
	X Walk 1 Width (in)	N/A		Clear Space?	N/A

X Walk 1 Slope (%)	3.6	N/A	Clear Space to XWalk (in)	N/A
	X Walk 1 X Slope (%)	3.0	N/A	Storm Grate/Utility Hazard?	N/A
N/A	Ramp inside XWalk1?	N/A		Storm Grate/Utility Type	
N/A	Any Obstructions?	N/A			N/A
	Obstruction Type		Yes	Surface Condition? (G/P)	Good
			N/A	Curb Slope (%)	11.6

**Remove & Replace Entire Ramp.**
