# Access Compliance Report

## Public Rights-of-Way

### (Curb Ramps)

| Intersection ID: 6998 | Main Street: NEVIN_RD | Cross Street: STATESVILLE_RD | Location: NE |

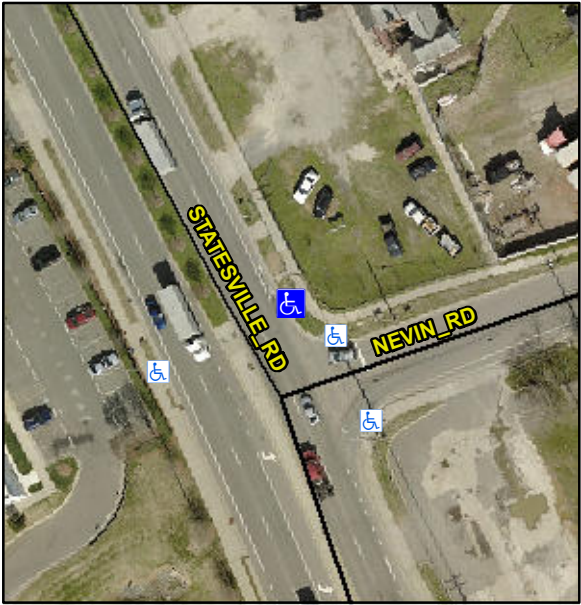
| ADA ID: 649C7B378213 | Ramp Type: Perp | Initial Pass/Fail: Fail | Overall Compliance: No |

| Codes/Mitigation Info/Possible Solution | | | Field Measurements/Component Compliance | | |
|---|--|--|---|---|---|
| | <b>Remove &amp; Replace Entire Ramp.</b> | | <b>No</b> | Ramp Length (in) | <b>96.0</b> |
| | | | <b>No</b> | Ramp Width (in) | <b>47.5</b> |
| <p>Surveyor Notes:</p> <p><b>N/A</b></p> <p>PROW/ADA:</p> <p><b>Not Found, R304.5.1, R304.2.2</b></p> | | | <b>N/A</b> | Flare Type RT | <b>N/A</b> |
| | | | <b>N/A</b> | Gutter Ponding? | <b>Yes</b> |

| Codes/Mitigation Info/Possible Solution | | | Field Measurements/Component Compliance | | |
|---|--|--|---|---|---|
| <p>Total Cost:</p> <p><b>\$ 1850.00</b></p> | | | <b>N/A</b> | Gutter Lip Ht (in) | <b>N/A</b> |
