# Access Compliance Report

## Public Rights-of-Way

### (Curb Ramps)

Intersection ID: 15555	Main Street: EASTOVER RIDGE DR	Cross Street: RANDOLPH RD	Location: SW
ADA ID: 64B22DC9A3EF	Ramp Type: PerpDiag	Initial Pass/Fail: Fail	Overall Compliance: No
Severity Score: 12.5			
Codes/Mitigation Info/Possible Solution		Field Measurements/Component Compliance

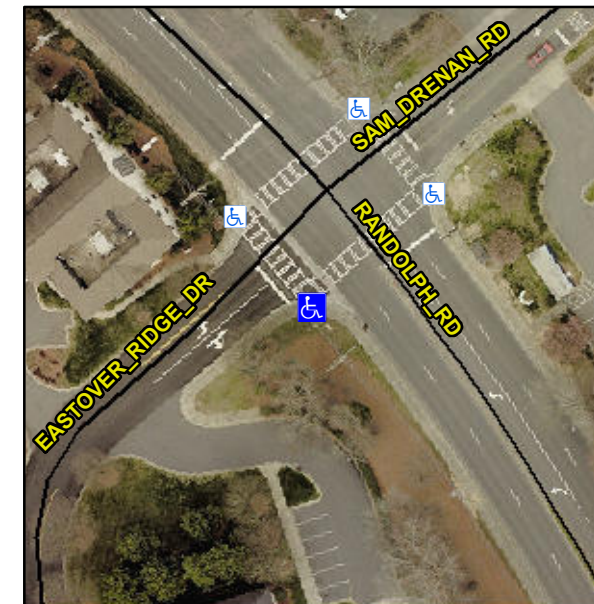
Compliance	Description	Data	Compliance	Description	Data
N/A	Ramp Length (in)	72.0	No	Ramp Slope (%)	10.1
Yes	Ramp Width (in)	48.0	Yes	Ramp XSlope (%)	1.9
N/A	Flare Type LT	N/A	N/A	Flare Type RT	N/A
N/A	Flare Slope LT (%)	N/A	N/A	Flare Slope RT (%)	N/A
N/A	Flare Traversable LT?	N/A	N/A	Flare Traversable RT?	N/A
N/A	Landing Length (in)	N/A	N/A	DWS Provided?	N/A
N/A	Landing Width (in)	N/A	N/A	DWS Contrast?	N/A
N/A	Landing Slope (%)	N/A	N/A	DWS Length (in)	N/A
N/A	Landing X Slope (%)	N/A	N/A	DWS Full Width?	N/A
N/A	Landing Curb? (Y/N)	N/A	N/A	DWS Offset (in)	N/A
N/A	Shared Landing?	N/A			
N/A	Gutter Ponding?	N/A	N/A	Gutter Slope (%)	N/A
N/A	Gutter Lip Ht (in)	N/A	N/A	Gutter X Slope (%)	N/A
N/A	Painted X Walk1?	Yes	N/A	Painted X Walk2?	Yes
	X Walk 1 Direction	To NE		X Walk 2 Direction	To NW
N/A	X Walk 1 Width (in)	81.0	N/A	X Walk 2 Width (in)	83.0
	X Walk 1 Slope (%)	6.6		X Walk 2 Slope (%)	1.2
	X Walk 1 X Slope (%)	0.9		X Walk 2 X Slope (%)	0.2

N/A	Ramp inside XWalk1?	No	N/A	Ramp inside XWalk2?	No
	Road Slope (%)	0.6	N/A	Clear Space?	N/A
	Road X Slope (%)	4.2	N/A	Clear Space to XWalk (in)	N/A
N/A	Any Obstructions?	N/A	N/A	Storm Grate/Utility Hazard?	N/A
	Obstruction Type			Storm Grate/Utility Type	
		N/A			N/A
		Yes		Surface Condition? (G/P)	Good

Possible Solutions:

**Remove & Replace Curb Ramp With Two New Directional Ramps or Equivalent. Restripe Crosswalk.**

**Not Found, R304.2.2**
