# Access Compliance Report

## Public Rights-of-Way

### (Curb Ramps)

Intersection ID: 9356	Main Street: E_36TH_ST	Cross Street: N_TRYON_ST	Location: SW
ADA ID: 64B2ACA0D407	Ramp Type: Perp	Initial Pass/Fail: Fail	Overall Compliance: No
		Severity Score: 42.5

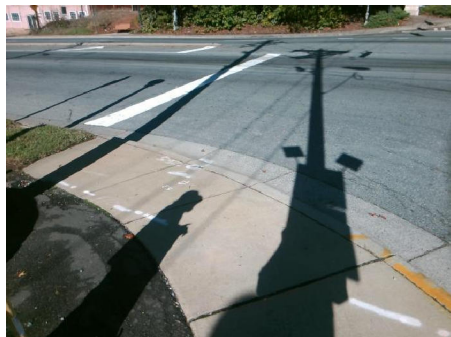
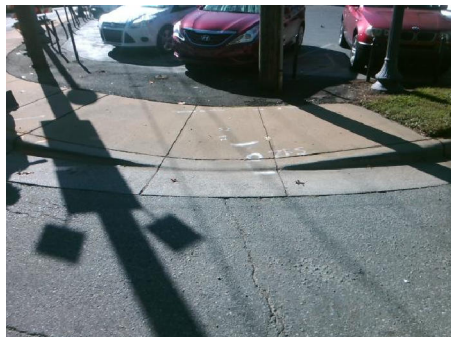
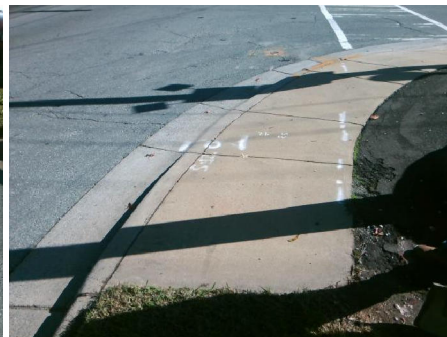
**Not Found, R304.5.1, R304.2.2, R304.5.3**

Compliance	Description	Data	Compliance	Description	Data
N/A	Ramp Length (in)	60.0	No	Ramp Slope (%)	9.2
No	Ramp Width (in)	35.5	No	Ramp XSlope (%)	5.3
N/A	Flare Type LT	N/A	N/A	Flare Type RT	N/A
N/A	Flare Slope LT (%)	N/A	N/A	Flare Slope RT (%)	N/A
N/A	Flare Traversable LT?	N/A	N/A	Flare Traversable RT?	N/A
N/A	Landing Length (in)	N/A	N/A	DWS Provided?	N/A
N/A	Landing Width (in)	N/A	N/A	DWS Contrast?	N/A
N/A	Landing Slope (%)	N/A	N/A	DWS Length (in)	N/A
N/A	Landing X Slope (%)	N/A	N/A	DWS Full Width?	N/A
N/A	Landing Curb? (Y/N)	N/A	N/A	DWS Offset (in)	N/A
N/A	Shared Landing?	N/A			
N/A	Gutter Ponding?	N/A	N/A	Gutter Slope (%)	N/A
N/A	Gutter Lip Ht (in)	N/A	N/A	Gutter X Slope (%)	N/A
N/A	Painted X Walk1?	No	N/A	Painted X Walk2?	N/A
	X Walk 1 Direction	To NW		X Walk 2 Direction	N/A
N/A	X Walk 1 Width (in)	N/A	N/A	X Walk 2 Width (in)	N/A
	X Walk 1 Slope (%)	4.2		X Walk 2 Slope (%)	N/A
	X Walk 1 X Slope (%)	4.5		X Walk 2 X Slope (%)	N/A

N/A	Ramp inside XWalk1?	N/A	N/A	Ramp inside XWalk2?	N/A
	Road Slope (%)	N/A	N/A	Clear Space?	N/A
	Road X Slope (%)	N/A	N/A	Clear Space to XWalk (in)	N/A
N/A	Any Obstructions?	N/A	N/A	Storm Grate/Utility Hazard?	N/A
	Obstruction Type			Storm Grate/Utility Type	
		N/A			N/A
			Yes	Surface Condition? (G/P)	Good

**Remove & Replace Entire Ramp.**

Total Cost: \$ 1850.00
