# Access Compliance Report

## Public Rights-of-Way

### (Curb Ramps)

| Intersection ID: 27273 | Main Street: ELMSTONE_DR | Cross Street: HASTINGS_MILL_LN | Location: NW |

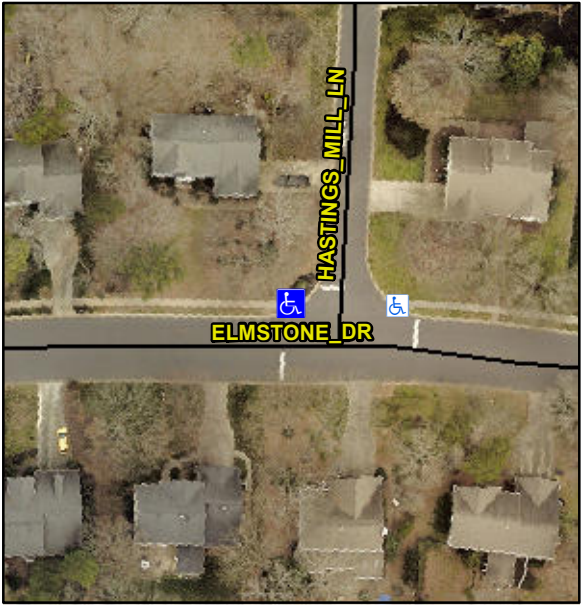
| ADA ID: 64BF8E44C7E6 | Ramp Type: Perpendicular Diagonal | Initial Pass/Fail: Fail | Overall Compliance: No |

| Codes/Mitigation Info/Possible Solution | | Field Measurements/Component Compliance | | | |
|---|---|---|---|---|---|
| | PROW/ADA: | Yes | No | Ramp Width (in) | 48.0 |
| | Not Found, R304.5.3 | N/A | N/A | Flare Type LT | N/A |

| Codes/Mitigation Info/Possible Solution | | Field Measurements/Component Compliance | | | |
|---|---|---|---|---|---|
| | Remove & Replace Curb Ramp With Two New Directional Ramps or Equivalent. | <b>Description</b> | <b>Data</b> | <b>Compliance</b> | <b>Description</b> |
